General Information

Make	Toyota	Model	Vios
YOM	2025	Odo Meter Reading	22,789
Registration No.	CCF3924	Chassis No.	PA1B18F33R4263986
CC	1.3	Transmission	CVT
Fuel Type	Gas	Type of Body	Sedan
Colour	Blackish Red Mica

Body / Panel Condition

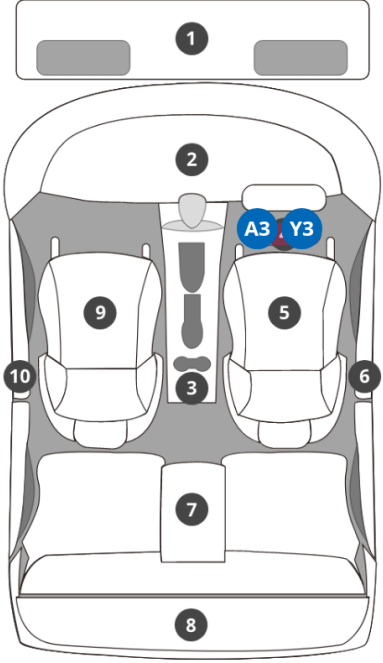
Interior Evaluation : B	Exterior Evaluation : E

<p>a : Cut, Fray d : Loose, Deformed k : Animal Hair s : Smell t : Cigarette Burns x : Defective y : Stain</p>

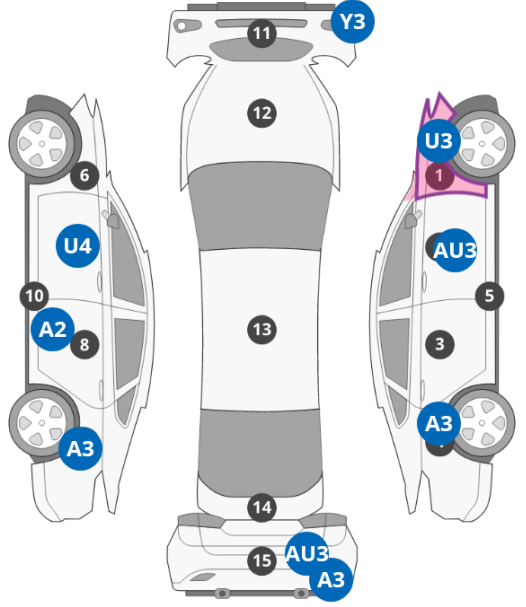
<p>A : Scratch AU : Scratch & Dent B : Modified C : Corrosion G : Stone chip P : Faded S : Rust SC : Rust & Corrosion U : Dent X : Defective Y : Crack, Gap</p>
Remarks (L) Front Floor Mat - Cut, Crack - Medium / (R) Front Floor Mat - Grime - Medium	Remarks (L) Front Door, Molding - Dent - Large / Front Bumper, Grille, Lamps - Crack, Gap - Medium / (R) Front Fender, Molding - Dent - Medium / (R) Front Door, Molding - Scratch & Dent - Medium / (R) Front Fender, Molding - Partially Missing - Yes / (R) Rear Fender, Molding - Scratch - Medium / Rear Bumper, Lamps, Panels - Scratch - Medium / Trunk Hood, Rear Gate - Scratch & Dent - Medium / (L) Rear Door, Molding - Scratch - Small / (L) Rear Fender, Molding - Scratch - Medium
Frame Evaluation : A	Functional Evaluation : A
