## General Information

| Make | Toyota | Model | Vios |

## Body / Panel Condition

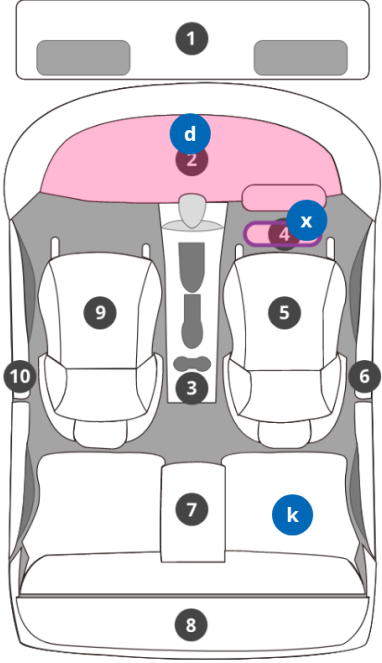
| Interior Evaluation : <b>B</b> | Exterior Evaluation : <b>D</b> |
| <p><b>Remarks</b></p> <p>Overall Interior - Animal Hair - Yes / (R) Front Floor Mat - Missing - Yes / Dashboard - Traces of Adhesive Tape - Yes</p> | <p><b>Remarks</b></p> <p>(R) Front Door, Molding - Scratch &amp; Dent - Large / (R) Rear Door, Molding - Scratch &amp; Dent - Large / (R) Mirror - Crack - Damaged / (R) Rear Fender, Molding - Dent - Small / Front Bumper, Grille, Lamps - Scratch - Medium / Rear Bumper, Lamps, Panels - Scratch - Medium / (R) Front Fender, Molding - Scratch &amp; Dent - Small / Trunk Hood, Rear Gate - Dent - Medium</p> |

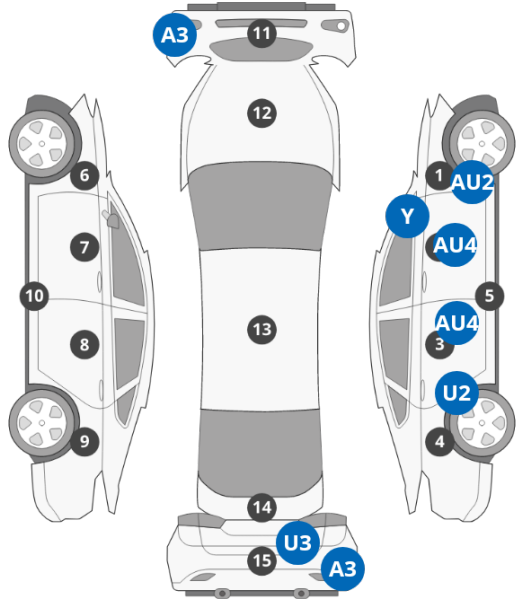
| Inspector Notes |
|---|
| <p>hanging passenger side mirror / no tools, no jack and warranty booklet</p> |
