## General Information

| Make | Toyota | Model | Vios |
| YOM | 2024 | Mileage | 16,980 |
| Registration No. | DBO2340 | Chassis No. | PA1B18F32P4236890 |

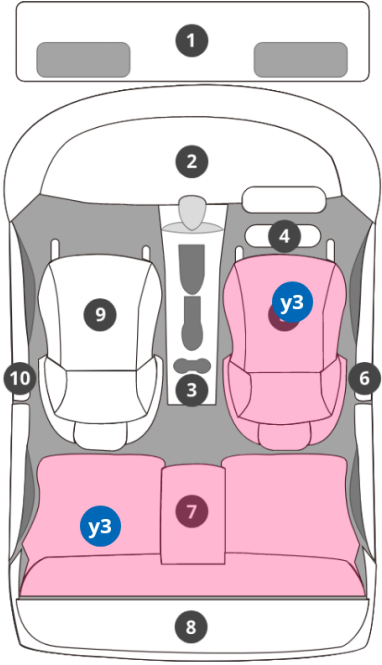
| Interior Evaluation : <b>B</b> | Exterior Evaluation : <b>C</b> |
|---|---|
| <b>Remarks</b><br>(R) Front Seat - Grime - Medium / Rear Seat - Grime - Medium | <b>Remarks</b><br>Member (Bolted) - Dent - Yes / Front Bumper, Grille, Lamps - Scratch - Medium / (R) Rear Fender, Molding - Dent - Small / Rear Bumper, Lamps, Panels - Scratch - Large / (L) Rear Fender, Molding - Scratch & Dent - Medium / (L) Rear Door, Molding - Scratch & Dent - Large / (L) Step, In-panel, Side Spoiler - Scratch & Dent - Medium / (R) Front Wheel, Cover - Scratch, Corrosion - Small / (L) Rear Wheel, Cover - Scratch, Corrosion - Small / (L) Front Wheel, Cover - Scratch, Corrosion - Small |
