## General Information

| Make | Toyota | Model | Vios |
| YOM | 2023 | Odo Meter Reading | 14,272 |

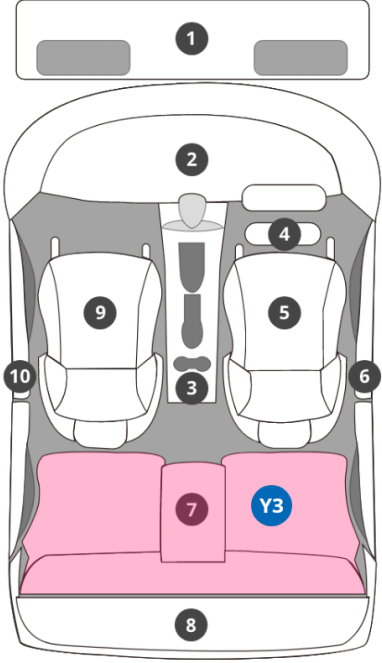
| Interior Evaluation : <b>B</b> | Exterior Evaluation : <b>C</b> |
| <b>Remarks</b><br>Rear Seat - Grime - Medium | <b>Remarks</b><br>Bonnet - Repair Traces - Yes / (L) Step, In-panel, Side Spoiler - Scratch & Dent - Small / (L) Rear Fender, Molding - Scratch & Dent - Small / Member (Bolted) - Dent - Yes / (R) Rear Fender, Molding - Scratch & Dent - Medium / Bonnet, Headlight - Repair mark - Yes / Bonnet, Headlight - Modified - Small / (R) Front Door, Molding - Scratch - Small / (R) Rear Door, Molding - Scratch - Minimal / Rear Bumper, Lamps, Panels - Scratch - Medium / Front Bumper, Grille, Lamps - Scratch - Small / Roof - Scratch & Dent - Small / (R) Front Fender, Molding - Scratch - Minimal / Trunk Hood, Rear Gate - Scratch & Dent - Minimal / (L) Front Fender, Molding - Scratch - Minimal / (L) Front Door, Molding - Scratch - Minimal / (L) Rear Door, Molding - Scratch - Minimal |

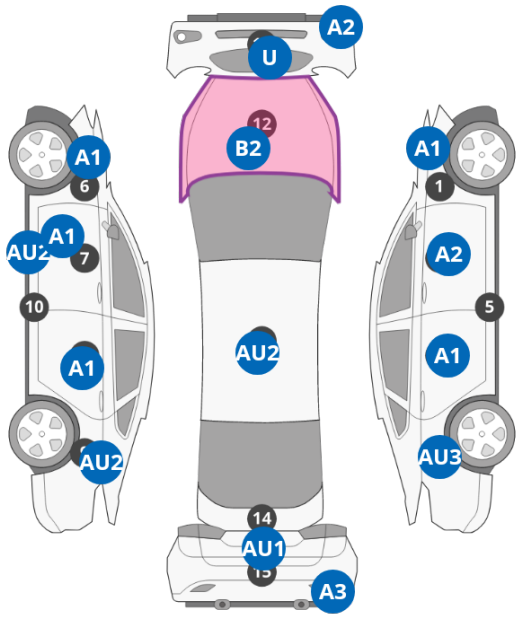
With LTO plate and warranty booklet, Sparetire and Jack, Incomplete Tools. Scratch headlight and tail light, Adhesive marks on vehicle and side mirror, worn tires.
