General Information

Make	Toyota	Model	Vios
YOM	2023	Odo Meter Reading	10,684
Registration No.	DBI5281	Chassis No.	PA1B18F34P4218908
CC	1.3	Transmission	CVT
Fuel Type	Gas	Type of Body	Sedan
Colour	Green

Body / Panel Condition

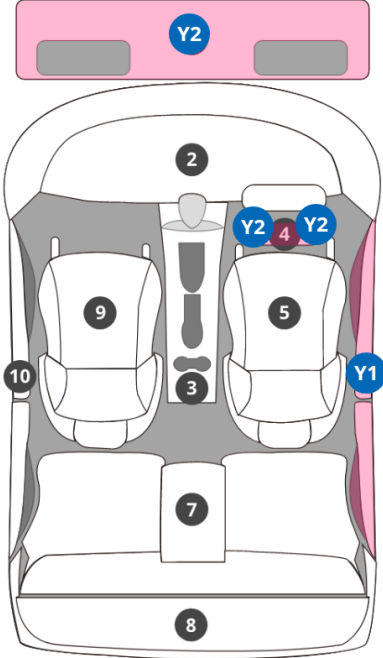
Interior Evaluation : A	Exterior Evaluation : C

<p>a : Cut, Fray d : Loose, Deformed k : Animal Hair s : Smell t : Cigarette Burns x : Defective y : Stain</p>

<p>A : Scratch AU : Scratch & Dent B : Modified C : Corrosion G : Stone chip P : Faded S : Rust SC : Rust & Corrosion U : Dent X : Defective Y : Crack, Gap</p>
<p>Remarks Ceiling - Grime - Small / (R) Front Trim - Grime - Minimal / (R) Front Floor Mat - Grime - Small / (L) Front Floor Mat - Grime - Small</p>	<p>Remarks Trunk Hood, Rear Gate - Repair Traces - Yes / (R) Mirror - Scratch - Small / (R) Front Door, Molding - Scratch & Dent - Medium / (R) Rear Fender, Molding - Scratch - Small / (R) Rear Door, Molding - Scratch - Large / Trunk Hood, Rear Gate - Scratch - Small / Rear Bumper, Lamps, Panels - Scratch - Small / (L) Rear Fender, Molding - Scratch - Small / (L) Mirror - Scratch - Small / (L) Rear Door, Molding - Scratch - Small / Front Bumper, Grille, Lamps - Scratch & Dent - Small</p>
