## General Information

| Make | Toyota | Model | Innova |

## Body / Panel Condition

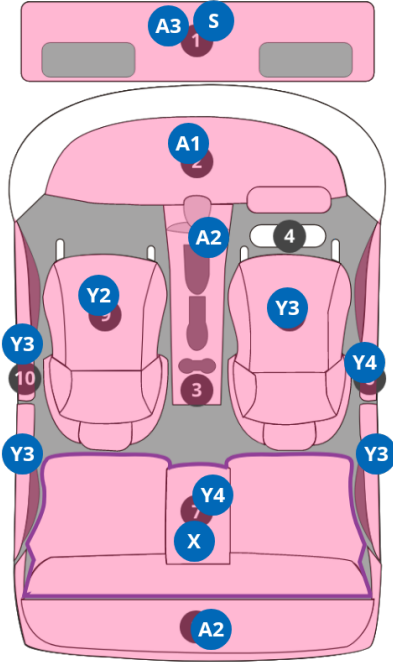
| Interior Evaluation : <b>E</b> | Exterior Evaluation : <b>E</b> |
| <b>Remarks</b><br>Trunk Room - Worn, Scratch, Cut, Crack - Small / Overall Interior - Smell - Yes / Overall Interior - Worn as per age - Yes / Rear Seat - Grime - Large / (R) Rear Trim - Grime - Medium / (R) Front Trim - Grime - Large / (R) Front Seat - Grime - Medium / (L) Rear Trim - Grime - Medium / (L) Front Trim - Grime - Medium / Ceiling - Cut, Crack - Medium / (L) Front Seat - Grime - Small / Dashboard - Worn, Scratch, Cut, Crack - Minimal / Console, Switches, Vents - Worn, Scratch, Cut, Crack - Small / Rear Seat Head Rest - Missing - Yes | <b>Remarks</b><br>Trunk Hood, Rear Gate - Repair Traces - Yes / (R) Rear Fender - Repair Traces - Yes / Trunk Hood, Rear Gate - Repair mark - Yes / (R) Rear Fender, Molding - Repair mark - Yes / (R) Front Fender, Molding - Dent - Large / (R) Front Door, Molding - Dent - Medium / (R) Rear Door, Molding - Scratch - Medium / (R) Rear Fender, Molding - Scratch & Dent - Large / Rear Bumper, Lamps, Panels - Crack, Gap - Large / Trunk Hood, Rear Gate - Scratch - Minimal / (L) Rear Fender, Molding - Scratch - Small / (L) Step, In-panel, Side Spoiler - Scratch & Dent - Large / (L) Rear Door, Molding - Scratch & Dent - Large / (L) Front Door, Molding - Scratch - Medium / (L) Mirror - Scratch - Small / (L) Front Fender, Molding - Scratch - Small / Roof - Scratch - Small / Front Bumper, Grille, Lamps - Scratch & Dent - Medium / Bonnet, Headlight - Scratch - Small / (R) Mirror - Crack - Damaged |
