General Information

Make	Toyota	Model	Vios
YOM	2023	Odo Meter Reading	37,286
Registration No.	CCA1542	Chassis No.	PA1B18F34P4221582
CC	1.3	Transmission	CVT
Fuel Type	Gas	Type of Body	Sedan
Colour	Blackish Red Mica

Body / Panel Condition

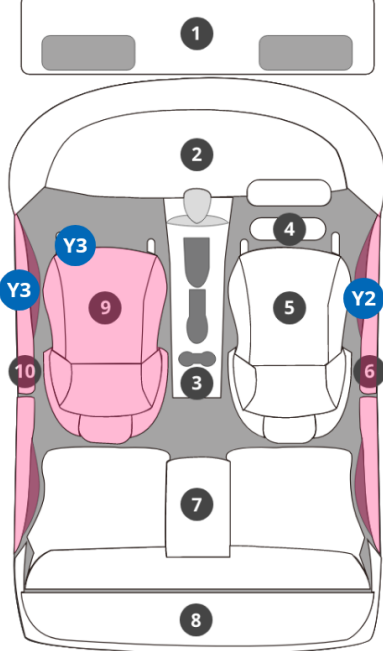
Interior Evaluation : B	Exterior Evaluation : E

<p>a : Cut, Fray d : Loose, Deformed k : Animal Hair s : Smell t : Cigarette Burns x : Defective y : Stain</p>

<p>A : Scratch AU : Scratch & Dent B : Modified C : Corrosion G : Stone chip P : Faded S : Rust SC : Rust & Corrosion U : Dent X : Defective Y : Crack, Gap</p>
<p>Remarks (L) Front Seat - Grime - Medium / (R) Front Trim - Grime - Small / (L) Front Trim - Grime - Medium</p>	<p>Remarks (L) Front Door - Repair Traces - Yes / (L) Step - Repair Traces - Yes / (L) Front Door, Molding - Repair mark - Yes / Rear Bumper, Lamps, Panels - Scratch - Large / (L) Rear Fender, Molding - Scratch - Medium / (L) Rear Door, Molding - Scratch - Small / Member (Bolted) - Dent - Yes / Front Bumper, Grille, Lamps - Scratch & Dent - Medium / Bonnet, Headlight - Scratch - Large / (R) Front Fender, Molding - Scratch & Dent - Medium / (R) Front Door, Molding - Scratch - Medium / (R) Rear Door, Molding - Scratch - Small / (R) Rear Fender, Molding - Scratch - Minimal / Trunk Hood, Rear Gate - Scratch & Dent - Small / (L) Step, In-panel, Side Spoiler - Scratch - Medium / (R) Step, In-panel, Side Spoiler - Scratch & Dent - Large</p>
