General Information

Make	Toyota	Model	Vios
YOM	2022	Odo Meter Reading	49,962
Registration No.	DAP5816	Chassis No.	PA1B18F34M4164442
CC	1.3	Transmission	CVT
Fuel Type	Gas	Type of Body	Sedan
Colour	Silver

Body / Panel Condition

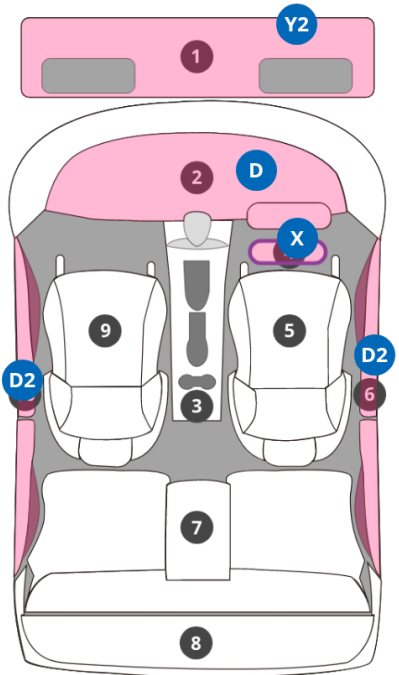
Interior Evaluation : B	Exterior Evaluation : E

<p>a : Cut, Fray d : Loose, Deformed k : Animal Hair s : Smell t : Cigarette Burns x : Defective y : Stain</p>

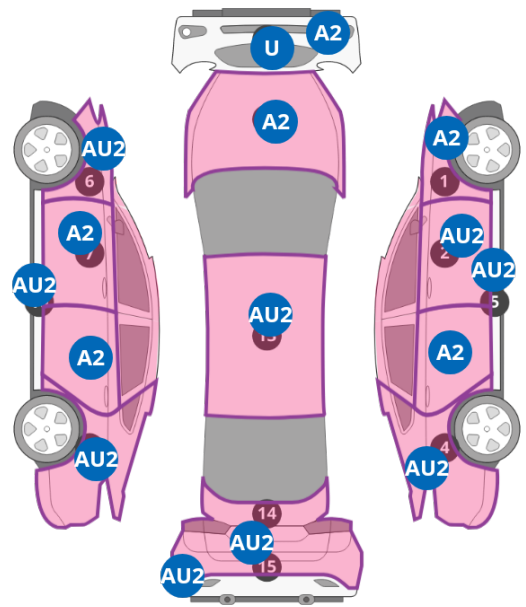
<p>A : Scratch AU : Scratch & Dent B : Modified C : Corrosion G : Stone chip P : Faded S : Rust SC : Rust & Corrosion U : Dent X : Defective Y : Crack, Gap</p>
<p>Remarks (L) Front Floor Mat - Missing - Yes / Ceiling - Grime - Small / Dashboard - Traces of Adhesive Tape - Yes / (L) Front Trim - Worked - Small / (R) Front Trim - Worked - Small</p>	<p>Remarks (R) Front Door - Repair Traces - Yes / (R) Front Fender - Repair Traces - Yes / Bonnet - Repair Traces - Yes / (L) Front Fender - Repair Traces - Yes / (L) Front Door - Repair Traces - Yes / (L) Rear Door - Repair Traces - Yes / (L) Rear Fender - Repair Traces - Yes / Trunk Hood, Rear Gate - Repair Traces - Yes / (R) Rear Fender - Repair Traces - Yes / (R) Rear Door - Repair Traces - Yes / Roof - Repair Traces - Yes / (R) Rear Fender, Molding - Repair mark - Yes / (L) Rear Fender, Molding - Repair mark - Yes / (L) Rear Door, Molding - Repair mark - Yes / (L) Front Door, Molding - Repair mark - Yes / (L) Front Fender, Molding - Repair mark - Yes / Bonnet, Headlight - Repair mark - Yes / (R) Front Fender, Molding - Repair mark - Yes / (R) Front Door, Molding - Repair mark - Yes / (R) Rear Door, Molding - Repair mark - Yes / Roof - Repair mark - Yes / Trunk Hood, Rear Gate - Repair mark - Yes / (L) Rear Fender, Molding - Scratch & Dent - Small / Rear Bumper, Lamps, Panels - Scratch & Dent - Small / Trunk Hood, Rear Gate - Scratch & Dent - Small / (R) Rear Fender, Molding - Scratch & Dent - Small / (R) Rear Door, Molding - Scratch - Small / (R) Front Door, Molding - Scratch & Dent - Small / (R) Step, In-panel, Side Spoiler - Scratch & Dent - Small / (L) Step, In-panel, Side Spoiler - Scratch & Dent - Small / (L) Rear Door, Molding - Scratch - Small / (L) Front Door, Molding - Scratch - Small / (L) Front Fender, Molding - Scratch & Dent - Small / Bonnet, Headlight - Scratch - Small / (R) Front Fender, Molding - Scratch - Small / Member (Bolted) - Dent - Yes / Front Bumper, Grille, Lamps - Scratch - Small / Roof - Scratch & Dent - Small</p>
