## General Information

| Make | Toyota | Model | Raize |
| Registration No. | DAR7816 | Chassis No. | MHKAA1BA4NJ051845 |

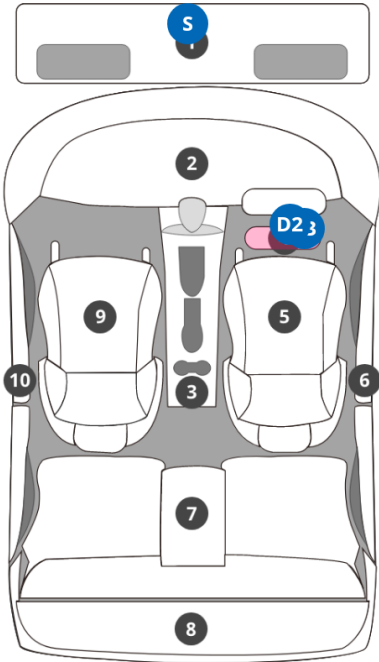
| Interior Evaluation : <span style="color: red;">B</span> | Exterior Evaluation : <span style="color: red;">C</span> |
| <b>Remarks</b><br>Overall Interior - Smell - Yes / (L) Front Floor Mat - Grime - Medium / (R) Front Floor Mat - Worked - Small | <b>Remarks</b><br>Front Windshield - Damaged - Large / Trunk Hood, Rear Gate - Scratch & Dent - Small / Rear Bumper, Lamps, Panels - Scratch & Dent - Small / (L) Rear Fender, Molding - Scratch - Minimal / (L) Rear Door, Molding - Scratch - Minimal / (L) Front Door, Molding - Scratch - Minimal / (L) Front Fender, Molding - Scratch - Minimal / Front Bumper, Grille, Lamps - Scratch - Minimal / (R) Front Fender, Molding - Scratch & Dent - Minimal / (R) Front Door, Molding - Scratch - Minimal / (R) Rear Door, Molding - Scratch - Minimal / (R) Rear Fender, Molding - Scratch - Minimal / Bonnet, Headlight - Scratch & Dent - Small / (R) Mirror - Scratch - Minimal / (L) Mirror - Scratch - Minimal / Roof - Scratch - Minimal |

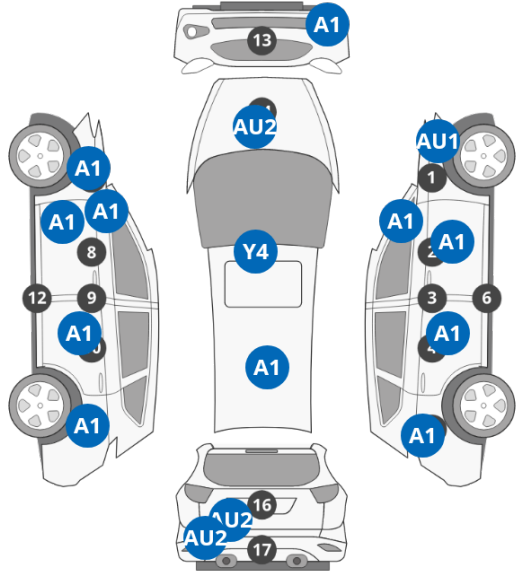
With LTO plate and Sparetire, Jack. No warranty booklet and Tools, scratch headlight and tail light and Crack front Windshield, Oil deterioration warning. park light and headlight switch won't work properly and suddenly off if you open the lights.
