## General Information

| Make | Toyota | Model | Hilux |
| YOM | 2024 | Odo Meter Reading | 41,825 |
| Registration No. | EAG6907 | Chassis No. | MR0BA3CD2P0197416 |

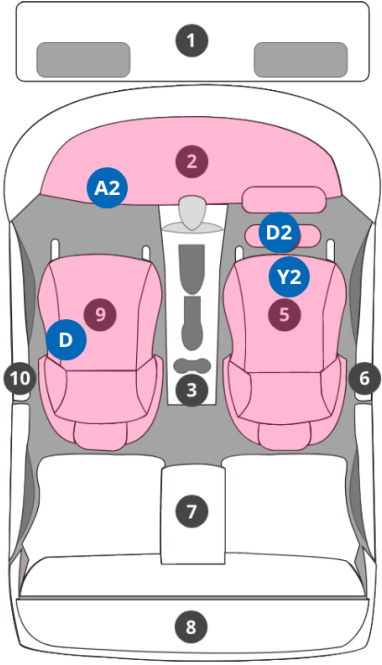
| Interior Evaluation : <b>B</b> | Exterior Evaluation : <b>D</b> |
| <p><b>Remarks</b><br/>(R) Front Seat - Grime - Small / (L) Front Seat - Worn - Yes / (L) Front Floor Mat - Worked - Small / Steering Wheel - Worn, Peel, Crack - Small</p> | <p><b>Remarks</b><br/>(R) Front Fender, Molding - Scratch - Minimal / (R) Front Door, Molding - Scratch - Minimal / (R) Rear Door, Molding - Scratch - Medium / (R) Side Gate - Scratch - Small / Rear Bumper, Lamps, Panels - Scratch - Small / Rear Gate - Scratch &amp; Dent - Small / (L) Side Gate - Scratch - Medium / (L) Mirror - Scratch - Small / (L) Front Door, Molding - Scratch &amp; Dent - Small / (L) Step, In-panel, Side Spoiler - Scratch - Small / (L) Rear Door, Molding - Scratch - Small / Front Bumper, Grille, Lamps - Scratch - Small / (L) Front Fender, Molding - Scratch - Minimal / Bonnet, Headlight - Scratch - Small / Roof - Scratch - Medium</p> |

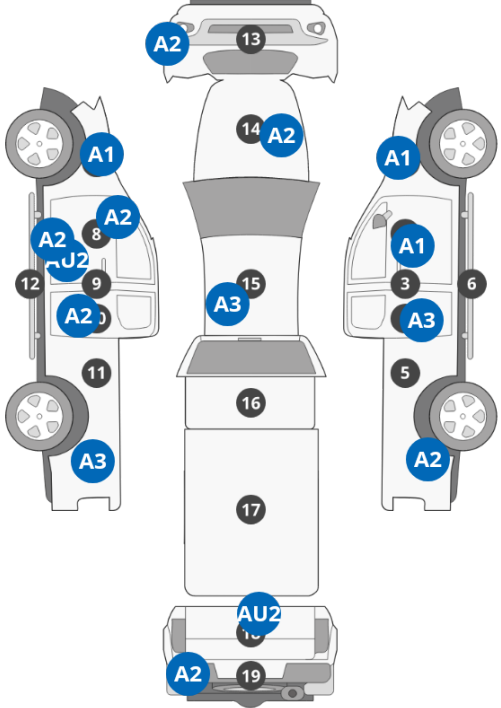
| Inspector Notes |
|---|
| no warranty booklet, no jack and tools, with spare tire, with LTO plate, scratches on tail light, battery weak |
