General Information

Make	Toyota	Model	Vios
YOM	2024	Odo Meter Reading	51,886
Registration No.	NHR8389	Chassis No.	PA1B18F30P4236435
CC	1.3	Transmission	CVT
Fuel Type	Gas	Type of Body	Sedan
Colour	Silver

Body / Panel Condition

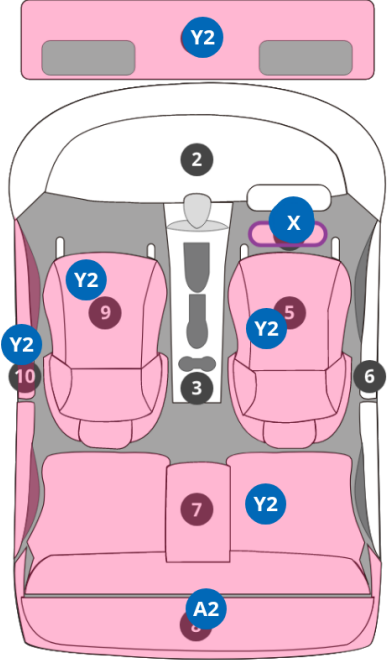
Interior Evaluation : B	Exterior Evaluation : C

<p>a : Cut, Fray d : Loose, Deformed k : Animal Hair s : Smell t : Cigarette Burns x : Defective y : Stain</p>

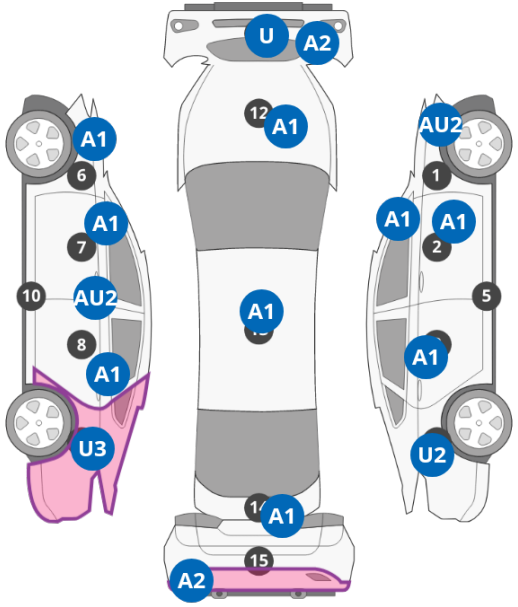
<p>A : Scratch AU : Scratch & Dent B : Modified C : Corrosion G : Stone chip P : Faded S : Rust SC : Rust & Corrosion U : Dent X : Defective Y : Crack, Gap</p>
<p>Remarks Trunk Room - Worn, Scratch, Cut, Crack - Small / (R) Front Floor Mat - Missing - Yes / (L) Front Floor Mat - Missing - Yes / Mat Other - Missing - Yes / Rear Seat - Grime - Small / (R) Front Seat - Grime - Small / (L) Front Seat - Grime - Small / Ceiling - Grime - Small / (L) Front Trim - Grime - Small</p>	<p>Remarks (L) Rear Fender - Repair Traces - Yes / Member (Bolted) - Dent - Yes / (R) Front Fender, Molding - Scratch & Dent - Small / (R) Front Door, Molding - Scratch - Minimal / (R) Rear Fender, Molding - Dent - Small / (R) Rear Door, Molding - Scratch - Minimal / Rear Bumper, Lamps, Panels - Repair mark - Yes / Rear Bumper, Lamps, Panels - Scratch - Small / (L) Rear Fender, Molding - Repair mark - Yes / Trunk Hood, Rear Gate - Scratch - Minimal / (L) Rear Fender, Molding - Dent - Medium / (L) Rear Door, Molding - Scratch - Minimal / (L) Front Door, Molding - Scratch & Dent - Small / (L) Front Fender, Molding - Scratch - Minimal / (L) Mirror - Scratch - Minimal / (R) Mirror - Scratch - Minimal / Front Bumper, Grille, Lamps - Scratch - Small / Roof - Scratch - Minimal / Bonnet, Headlight - Scratch - Minimal</p>
