## General Information

| Make | Toyota | Model | Vios |

## Body / Panel Condition

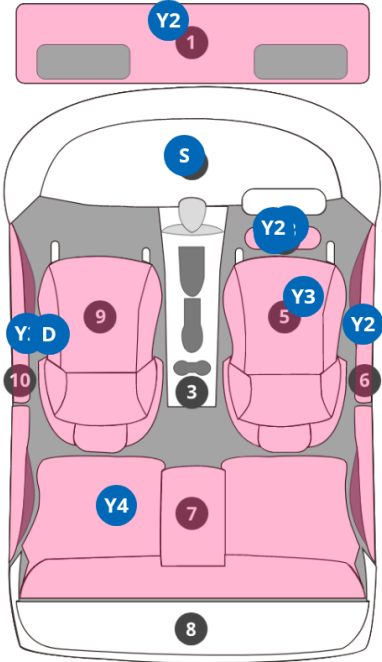
| Interior Evaluation : <b>C</b> | Exterior Evaluation : <b>E</b> |
| <p><b>Remarks</b></p> <p>Rear Seat - Grime - Large / (R) Front Seat - Grime - Medium / (R) Front Trim - Grime - Small / (L) Front Floor Mat - Cut, Crack - Medium / Overall Interior - Smell - Yes / Ceiling - Grime - Small / Mat Other - Grime - Medium / (L) Front Trim - Grime - Small / (L) Front Seat - Worn - Yes / (L) Front Floor Mat - Worked - Small</p> | <p><b>Remarks</b></p> <p>(R) Front Fender, Molding - Scratch - Small / (R) Mirror - Scratch - Medium / (R) Front Door, Molding - Scratch &amp; Dent - Large / (R) Rear Door, Molding - Scratch &amp; Dent - Medium / (R) Step, In-panel, Side Spoiler - Scratch &amp; Dent - Medium / (R) Rear Fender, Molding - Scratch &amp; Dent - Small / Rear Bumper, Lamps, Panels - Scratch - Medium / Trunk Hood, Rear Gate - Scratch &amp; Dent - Small / (L) Rear Fender, Molding - Scratch &amp; Dent - Small / (L) Step, In-panel, Side Spoiler - Scratch &amp; Dent - Medium / (L) Rear Door, Molding - Scratch - Small / (L) Front Door, Molding - Scratch &amp; Dent - Medium / (L) Mirror - Scratch - Small / (L) Front Fender, Molding - Scratch - Small / Bonnet, Headlight - Scratch &amp; Dent - Medium / Front Bumper, Grille, Lamps - Scratch - Medium / Roof - Scratch - Small</p> |

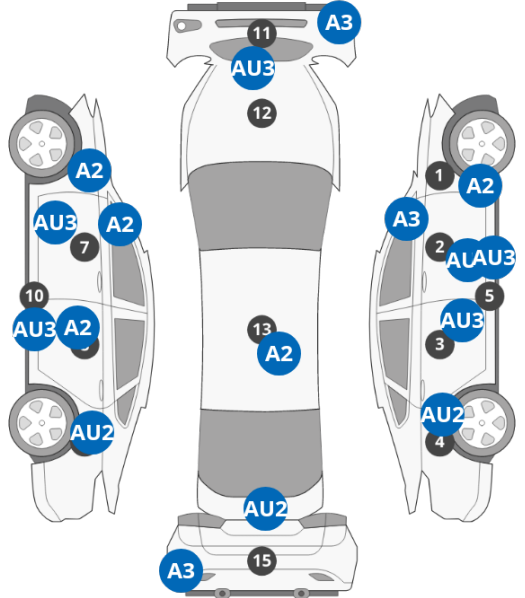
| Inspector Notes |
|---|
| no warranty booklet, no jack, incomplete tools, with spare tire, with LTO plate, scratches on tail light, resin stain on trunk and engine hood and roof, |
