## General Information

| Make | Toyota | Model | Vios |
| Registration No. | DBG3327 | Chassis No. | PA1B18F38N4199261 |

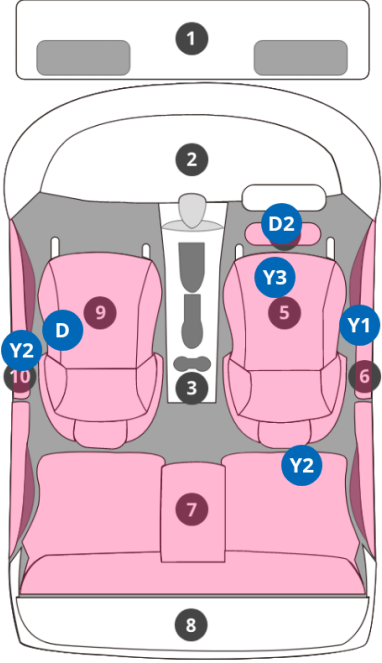
| Interior Evaluation : <b>B</b> | Exterior Evaluation : <b>B</b> |
| <p><b>Remarks</b></p> <p>Rear Seat - Grime - Small / (R) Front Seat - Grime - Medium / (L) Front Seat - Worn - Yes / (R) Front Trim - Grime - Minimal / (L) Front Trim - Grime - Small / (L) Front Floor Mat - Worked - Small</p> | <p><b>Remarks</b></p> <p>(R) Front Fender, Molding - Scratch - Minimal / (R) Mirror - Scratch - Minimal / (R) Front Door, Molding - Scratch - Small / (R) Rear Door, Molding - Scratch - Minimal / (R) Rear Fender, Molding - Scratch - Minimal / Rear Bumper, Lamps, Panels - Scratch - Minimal / Trunk Hood, Rear Gate - Scratch &amp; Dent - Minimal / (L) Rear Fender, Molding - Scratch &amp; Dent - Minimal / (L) Front Door, Molding - Scratch - Minimal / (L) Rear Door, Molding - Dent - Small / Member (Bolted) - Dent - Yes / Front Bumper, Grille, Lamps - Scratch - Minimal / Bonnet, Headlight - Scratch - Minimal / Roof - Scratch - Minimal</p> |

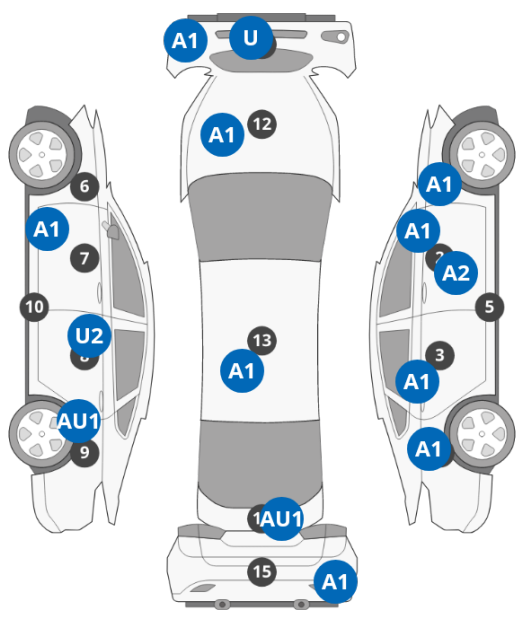
| Inspector Notes |
|---|
| with warranty booklet, with jack and tools, with spare tire, with LTO plate, scratches on tail, retractable mirror issue left side |
