## General Information

| Make | Toyota | Model | Vios |
| Registration No. | DBH6428 | Chassis No. | PA1B18F31P4208563 |

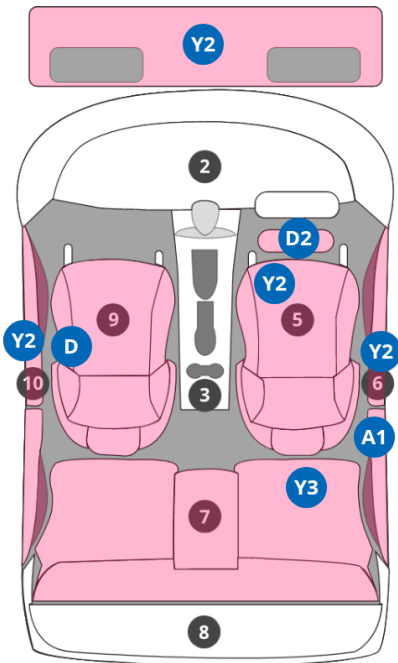
| Interior Evaluation : <span style="color: red;">C</span> | Exterior Evaluation : <span style="color: red;">D</span> |
|---|---|
| <b>Remarks</b><br>(R) Front Seat - Grime - Small / (L) Front Seat - Worn - Yes / Rear Seat - Grime - Medium / (R) Rear Trim - Cut, Crack - Minimal / (R) Front Trim - Grime - Small / (L) Front Trim - Grime - Small / (L) Front Floor Mat - Worked - Small / Ceiling - Grime - Small | <b>Remarks</b><br>(R) Front Door - Repair Traces - Yes / (R) Front Fender - Repair Traces - Yes / Bonnet - Repair Traces - Yes / (L) Front Fender - Repair Traces - Yes / (L) Front Door - Repair Traces - Yes / (L) Rear Door - Repair Traces - Yes / (L) Rear Fender - Repair Traces - Yes / (R) Rear Door - Repair Traces - Yes / (R) Front Fender, Molding - Scratch - Small / (R) Mirror - Scratch - Minimal / (R) Front Door, Molding - Dent - Medium / (R) Step, In-panel, Side Spoiler - Scratch & Dent - Medium / (R) Rear Door, Molding - Scratch - Small / (R) Rear Fender, Molding - Scratch - Medium / Rear Bumper, Lamps, Panels - Scratch & Dent - Minimal / Trunk Hood, Rear Gate - Dent - Minimal / (L) Rear Fender, Molding - Dent - Small / (L) Step, In-panel, Side Spoiler - Scratch - Small / (L) Rear Door, Molding - Scratch - Small / (L) Mirror - Stuck - Yes / (L) Front Door, Molding - Scratch - Small / Member (Bolted) - Dent - Yes / Front Bumper, Grille, Lamps - Crack, Gap - Large / Bonnet, Headlight - Dent - Medium / Roof - Scratch - Minimal |
