General Information

Make	Toyota	Model	Vios
YOM	2024	Odo Meter Reading	43,280
Registration No.	NFR6060	Chassis No.	PA1B18F34R4249836
CC	1.3	Transmission	CVT
Fuel Type	Gas	Type of Body	Sedan
Colour	Silver

Body / Panel Condition

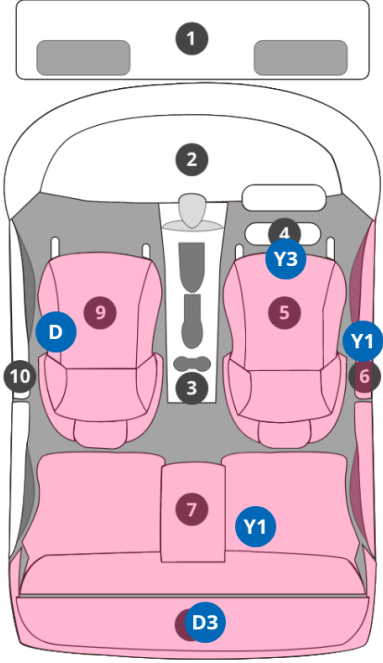
Interior Evaluation : B	Exterior Evaluation : E

<p>a : Cut, Fray d : Loose, Deformed k : Animal Hair s : Smell t : Cigarette Burns x : Defective y : Stain</p>

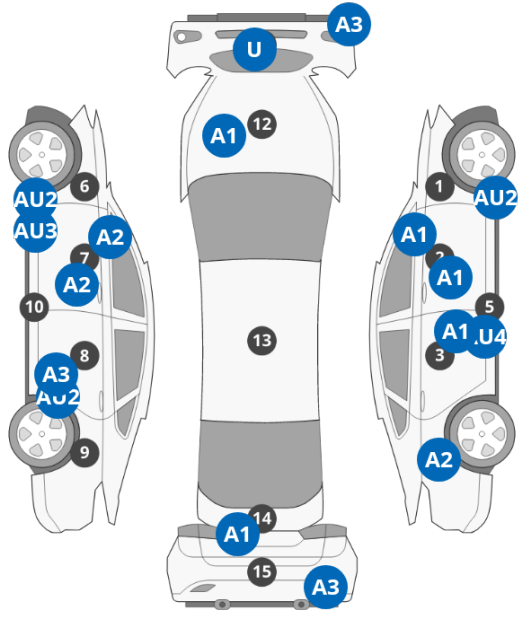
<p>A : Scratch AU : Scratch & Dent B : Modified C : Corrosion G : Stone chip P : Faded S : Rust SC : Rust & Corrosion U : Dent X : Defective Y : Crack, Gap</p>
<p>Remarks (R) Front Seat - Grime - Medium / (L) Front Seat - Worn - Yes / Rear Seat - Grime - Minimal / (R) Front Trim - Grime - Minimal / Trunk Room - Loose, Deformed - Medium</p>	<p>Remarks (R) Mirror - Scratch - Minimal / (R) Step, In-panel, Side Spoiler - Scratch & Dent - Large / (R) Front Fender, Molding - Scratch & Dent - Small / (R) Rear Door, Molding - Scratch - Minimal / (R) Front Door, Molding - Scratch - Minimal / (R) Rear Fender, Molding - Scratch - Small / Rear Bumper, Lamps, Panels - Scratch - Medium / Trunk Hood, Rear Gate - Scratch - Minimal / (L) Rear Fender, Molding - Scratch & Dent - Small / (L) Rear Door, Molding - Scratch - Medium / (L) Front Fender, Molding - Scratch & Dent - Small / (L) Step, In-panel, Side Spoiler - Scratch & Dent - Medium / (L) Front Door, Molding - Scratch - Small / (L) Mirror - Scratch - Small / Member (Bolted) - Dent - Yes / Front Bumper, Grille, Lamps - Scratch - Medium / Bonnet, Headlight - Scratch - Minimal</p>
