## General Information

| Make | Toyota | Model | Vios |
| YOM | 2021 | Odo Meter Reading | 61,151 |
| Registration No. | NGB6719 | Chassis No. | PA1B18F37L4123589 |

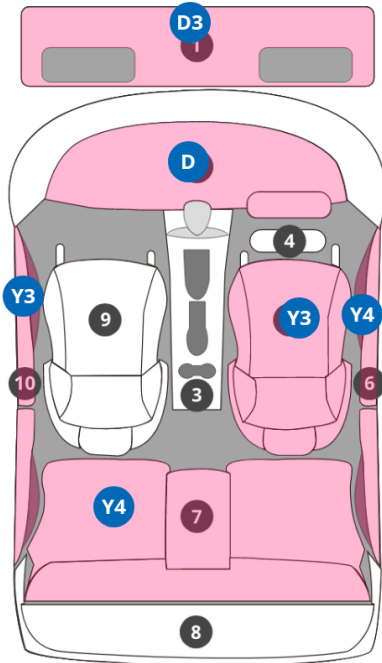
| Interior Evaluation : <b>C</b> | Exterior Evaluation : <b>E</b> |
|---|---|
| <p><b>Remarks</b></p> <p>Dashboard - Traces of Adhesive Tape - Yes / Rear Seat - Grime - Large / (L) Front Trim - Grime - Medium / (R) Front Trim - Grime - Large / (R) Front Seat - Grime - Medium / Ceiling - Crinkle - Medium</p> | <p><b>Remarks</b></p> <p>Bonnet, Headlight - Scratch - Large / (L) Front Door, Molding - Scratch - Small / (L) Rear Fender, Molding - Scratch - Small / Rear Bumper, Lamps, Panels - Scratch - Large / Trunk Hood, Rear Gate - Dent - Large / (R) Rear Fender, Molding - Scratch - Small / (R) Rear Door, Molding - Scratch - Medium / (R) Front Door, Molding - Scratch &amp; Dent - Small / (R) Front Fender, Molding - Crack, Gap - Medium / Front Bumper, Grille, Lamps - Scratch - Medium / (L) Front Fender, Molding - Scratch - Small / (L) Rear Door, Molding - Scratch - Minimal / Roof - Dent - Large / Front Windshield - Damaged - Large</p> |
