General Information

Make	Toyota	Model	Vios
YOM	2024	Odo Meter Reading	5,143
Registration No.	NFF5056-1	Chassis No.	PA1B18F36P4237718
CC	1.3	Transmission	CVT
Fuel Type	Gas	Type of Body	Sedan
Colour	Black

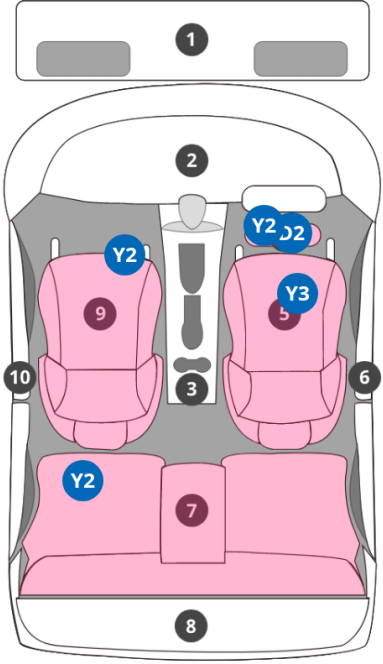
Interior Evaluation : B	Exterior Evaluation : C

<p>a : Cut, Fray d : Loose, Deformed k : Animal Hair s : Smell t : Cigarette Burns x : Defective y : Stain</p>

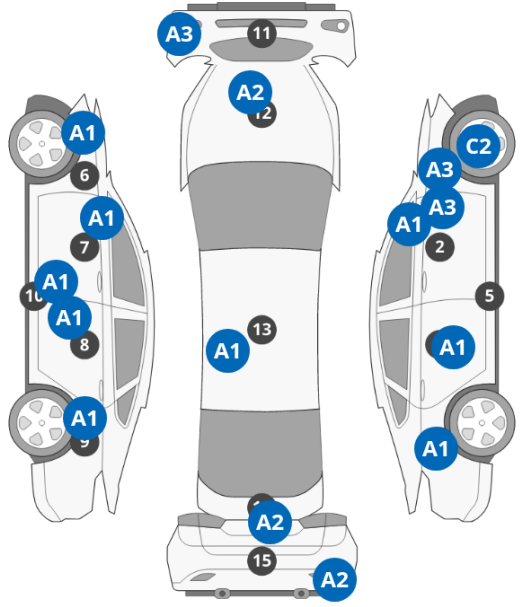
<p>A : Scratch AU : Scratch & Dent B : Modified C : Corrosion G : Stone chip P : Faded S : Rust SC : Rust & Corrosion U : Dent X : Defective Y : Crack, Gap</p>
<p>Remarks (L) Front Seat - Grime - Small / Rear Seat - Grime - Small / Mat Other - Crinkle - Small / (R) Front Seat - Grime - Medium / (L) Front Floor Mat - Grime - Small</p>	<p>Remarks (R) Front Fender, Molding - Scratch - Medium / (R) Front Door, Molding - Scratch - Medium / (R) Rear Door, Molding - Scratch - Minimal / (R) Rear Fender, Molding - Scratch - Minimal / (R) Front Wheel, Cover - Scratch, Corrosion - Small / Rear Bumper, Lamps, Panels - Scratch - Small / Trunk Hood, Rear Gate - Scratch - Small / (L) Rear Fender, Molding - Scratch - Minimal / (L) Rear Door, Molding - Scratch - Minimal / (L) Front Door, Molding - Scratch - Minimal / (L) Mirror - Scratch - Minimal / (R) Mirror - Scratch - Minimal / (L) Front Fender, Molding - Scratch - Minimal / Front Bumper, Grille, Lamps - Scratch - Medium / Bonnet, Headlight - Scratch - Small / Roof - Scratch - Minimal</p>
