## General Information

| Make | Toyota | Model | Hilux |
| Registration No. | DAQ5978 | Chassis No. | MR0JB8DD4N3540565 |

## Body / Panel Condition

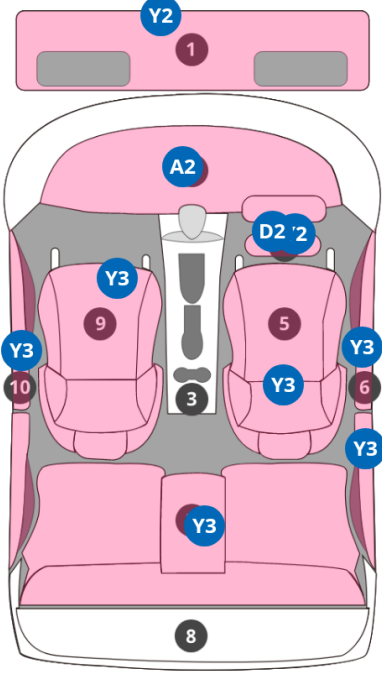
| Interior Evaluation : <b>C</b> | Exterior Evaluation : <b>E</b> |
|---|---|
| <p><b>Remarks</b><br/>Ceiling - Grime - Small / (L) Front Trim - Grime - Medium / (L) Front Seat - Grime - Medium / (R) Front Seat - Grime - Medium / Rear Seat - Grime - Medium / (R) Rear Trim - Grime - Medium / (R) Front Trim - Grime - Medium / Mat Other - Grime - Small / Overall Interior - Worn as per age - Yes / Dashboard - Worn, Scratch, Cut, Crack - Small</p> | <p><b>Remarks</b><br/>(R) Front Fender, Molding - Scratch &amp; Dent - Small / (R) Mirror - Scratch - Minimal / (R) Front Door, Molding - Scratch - Small / (R) Rear Door, Molding - Repair mark - Yes / (R) Rear Door, Molding - Scratch - Large / (R) Side Gate - Scratch &amp; Dent - Small / Rear Gate - Scratch - Small / Rear Bumper, Lamps, Panels - Scratch &amp; Dent - Medium / (L) Side Gate - Scratch - Small / (L) Rear Door, Molding - Scratch - Small / (L) Front Door, Molding - Scratch - Small / (L) Mirror - Scratch - Small / (L) Front Fender, Molding - Scratch - Small / Front Bumper, Grille, Lamps - Scratch - Large / Bonnet, Headlight - Scratch - Small / Roof - Scratch - Small</p> |

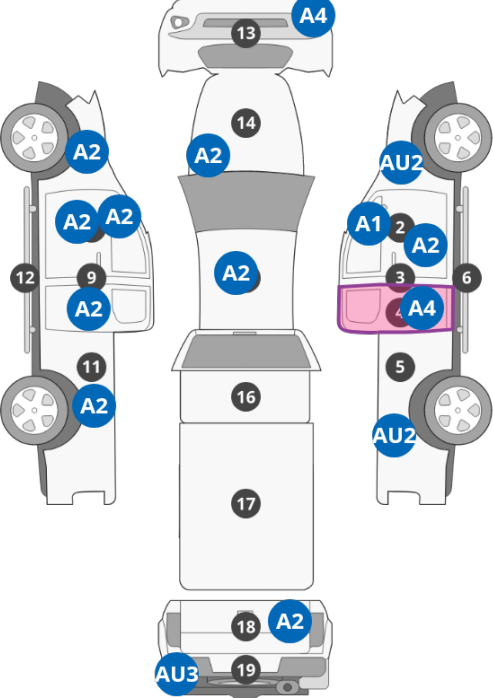
no warranty booklet, no jack and tools, with LTO plate, scratches on tail light, with spare tire, Original spare tire already installed, Replacement (damaged).
