General Information

Make	Toyota	Model	Innova
YOM	2025	Odo Meter Reading	8,966
Registration No.	NHS8310	Chassis No.	PA2JA8EM5R0147004
CC	2.8	Transmission	A/T
Fuel Type	Diesel	Type of Body	Wagon
Colour	Red Mica Metallic

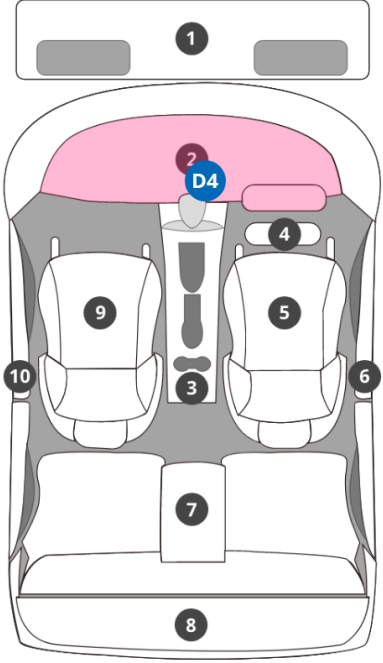
Interior Evaluation : C	Exterior Evaluation : D

<p>a : Cut, Fray d : Loose, Deformed k : Animal Hair s : Smell t : Cigarette Burns x : Defective y : Stain</p>

<p>A : Scratch AU : Scratch & Dent B : Modified C : Corrosion G : Stone chip P : Faded S : Rust SC : Rust & Corrosion U : Dent X : Defective Y : Crack, Gap</p>
Remarks Dashboard - Loose, Deformed - Large	Remarks Trunk Hood, Rear Gate - Repair Traces - Yes / Trunk Hood, Rear Gate - Repair mark - Yes / Member (Bolted) - Dent - Yes / (L) Rear Fender, Molding - Scratch & Dent - Small / (L) Rear Door, Molding - Scratch - Small / (L) Step, In-panel, Side Spoiler - Crack, Gap - Small / Front Bumper, Grille, Lamps - Scratch & Dent - Large / (R) Front Fender, Molding - Scratch - Large / Rear Bumper, Lamps, Panels - Crack, Gap - Large / Bonnet, Headlight - Scratch - Small / (R) Front Door, Molding - Scratch - Small / (R) Step, In-panel, Side Spoiler - Scratch - Small / (R) Rear Door, Molding - Scratch - Small
