General Information

Make	Toyota	Model	Lite Ace
YOM	2024	Odo Meter Reading	6,945
Registration No.	EAJ5181	Chassis No.	MHKB3FE10RK004206
CC	1.5	Transmission	M/T
Fuel Type	Gas	Type of Body	Utility Cargo
Colour	White

Body / Panel Condition

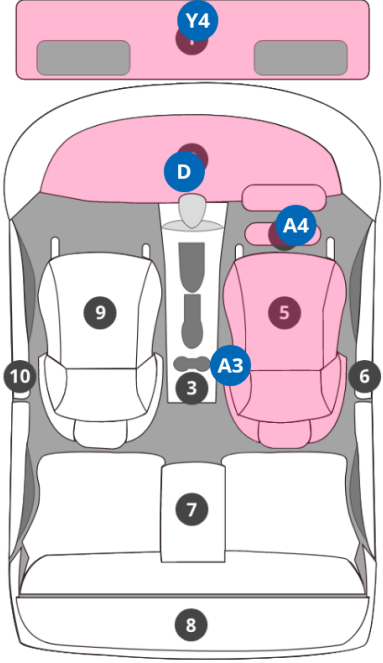
Interior Evaluation : C	Exterior Evaluation : D

<p>a : Cut, Fray d : Loose, Deformed k : Animal Hair s : Smell t : Cigarette Burns x : Defective y : Stain</p>

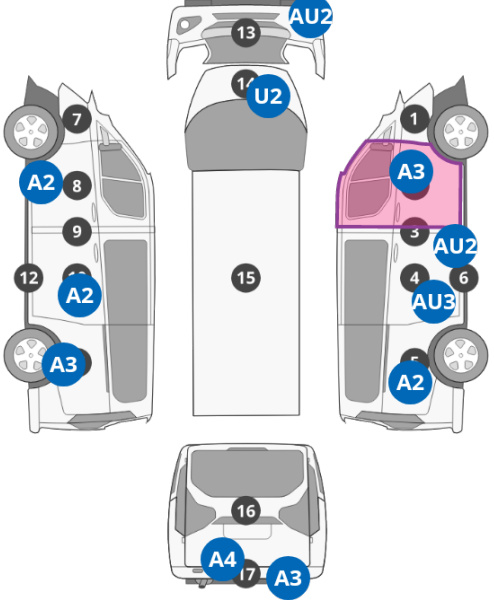
<p>A : Scratch AU : Scratch & Dent B : Modified C : Corrosion G : Stone chip P : Faded S : Rust SC : Rust & Corrosion U : Dent X : Defective Y : Crack, Gap</p>
<p>Remarks Overall Interior - Worn as per age - Yes / Carpet - Worn, Scratch, Cut, Crack - Large / Dashboard - Traces of Adhesive Tape - Yes / Ceiling - Grime - Large / (R) Front Seat - Cut, Crack - Medium</p>	<p>Remarks (R) Front Door, Molding - Scratch - Medium / (R) Front Door, Molding - Repair mark - Yes / (R) Rear Door, Molding - Scratch & Dent - Medium / (R) Step, In-panel, Side Spoiler - Scratch & Dent - Small / Rear Bumper, Lamps, Panels - Scratch - Medium / (L) Rear Fender, Molding - Scratch - Medium / Bonnet, Headlight - Dent - Small / Front Bumper, Grille, Lamps - Scratch & Dent - Small / Trunk Hood, Rear Gate - Scratch - Large / (L) Rear Door, Molding - Scratch - Small / (L) Front Door, Molding - Scratch - Small / (R) Rear Fender, Molding - Scratch - Small</p>
