## General Information

| Make | Toyota | Model | Vios |
| YOM | 2022 | Odo Meter Reading | 31,125 |

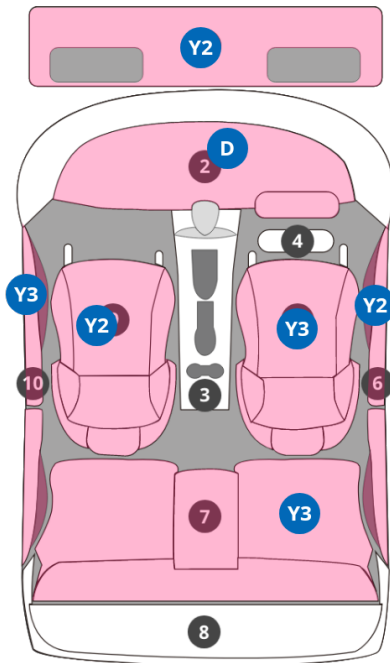
| Interior Evaluation : <b>C</b> | Exterior Evaluation : <b>D</b> |
| <p><b>a</b> : Cut, Fray <b>d</b> : Loose, Deformed <b>k</b> : Animal Hair <b>s</b> : Smell <b>t</b> : Cigarette Burns <b>x</b> : Defective <b>y</b> : Stain</p> | <p><b>A</b> : Scratch <b>AU</b> : Scratch &amp; Dent <b>B</b> : Modified <b>C</b> : Corrosion <b>G</b> : Stone chip <b>P</b> : Faded <b>S</b> : Rust <b>SC</b> : Rust &amp; Corrosion <b>U</b> : Dent <b>X</b> : Defective <b>Y</b> : Crack, Gap</p> |
| <p><b>Remarks</b></p> <p>Rear Seat - Grime - Medium / (R) Front Trim - Grime - Small / Dashboard - Traces of Adhesive Tape - Yes / (R) Front Seat - Grime - Medium / (L) Front Seat - Grime - Small / Ceiling - Grime - Small / (L) Front Trim - Grime - Medium</p> | <p><b>Remarks</b></p> <p>(L) Front Fender - Repair Traces - Yes / (L) Front Fender, Molding - Repair mark - Yes / Bonnet, Headlight - Scratch - Small / Front Bumper, Grille, Lamps - Scratch - Medium / (L) Front Door, Molding - Scratch - Medium / (L) Rear Door, Molding - Scratch - Medium / (L) Rear Fender, Molding - Scratch - Small / Rear Bumper, Lamps, Panels - Scratch - Small / Trunk Hood, Rear Gate - Scratch - Minimal / Roof - Scratch &amp; Dent - Small / (R) Front Fender, Molding - Scratch - Small / (R) Mirror - Scratch - Minimal / (R) Front Door, Molding - Scratch - Medium / (R) Rear Door, Molding - Scratch - Small / (R) Rear Fender, Molding - Scratch - Medium</p> |
