General Information

Make	Toyota	Model	Vios
YOM	2024	Odo Meter Reading	12,850
Registration No.	NHM3349	Chassis No.	PA1B18F35R4238992
CC	1.3	Transmission	CVT
Fuel Type	Gas	Type of Body	Sedan
Colour	Silver

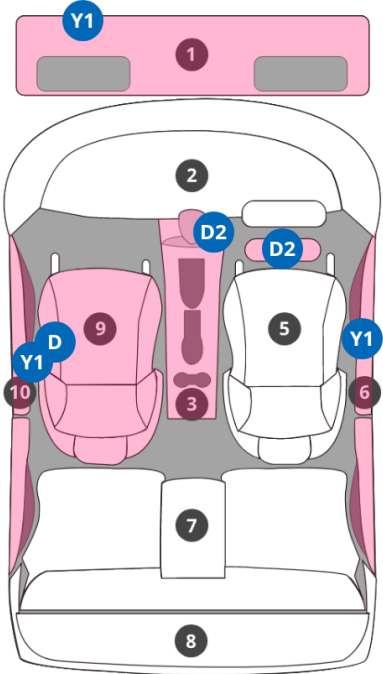
Interior Evaluation : B	Exterior Evaluation : D

<p>a : Cut, Fray d : Loose, Deformed k : Animal Hair s : Smell t : Cigarette Burns x : Defective y : Stain</p>

<p>A : Scratch AU : Scratch & Dent B : Modified C : Corrosion G : Stone chip P : Faded S : Rust SC : Rust & Corrosion U : Dent X : Defective Y : Crack, Gap</p>
Remarks (L) Front Seat - Worn - Yes / (R) Front Trim - Grime - Minimal / (L) Front Floor Mat - Worked - Small / (L) Front Trim - Grime - Minimal / Console, Switchs, Vents - Loose, Deformed - Small / Ceiling - Grime - Minimal	Remarks Member (Bolted) - Dent - Yes / (R) Front Fender, Molding - Scratch - Small / (R) Mirror - Scratch - Minimal / (L) Step, In-panel, Side Spoiler - Scratch & Dent - Medium / (R) Front Door, Molding - Scratch - Small / (R) Rear Door, Molding - Scratch - Small / (R) Rear Fender, Molding - Scratch - Small / Rear Bumper, Lamps, Panels - Scratch & Dent - Small / Trunk Hood, Rear Gate - Crack, Gap - Small / (L) Rear Fender, Molding - Scratch & Dent - Small / (L) Front Door, Molding - Scratch - Small / (L) Rear Door, Molding - Scratch - Small / (L) Mirror - Scratch - Minimal / (L) Front Fender, Molding - Scratch - Minimal / Front Bumper, Grille, Lamps - Crack, Gap - Medium / Bonnet, Headlight - Dent - Medium / Roof - Dent - Minimal

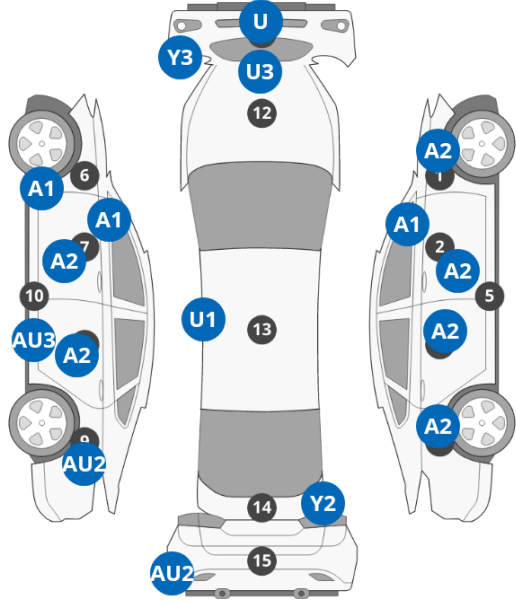
Inspector Notes
no warranty booklet, with jack and tools, with spare tire, with LTO plate, scratches on tail light
