## General Information

| Make | Toyota | Model | Vios |
| YOM | 2023 | Odo Meter Reading | 13,257 |
| Registration No. | NKH9749 | Chassis No. | PA1B18F39P4219262 |

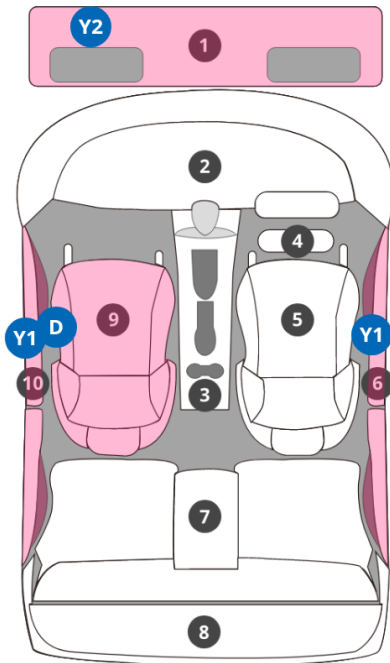
| Interior Evaluation : <b>B</b> | Exterior Evaluation : <b>C</b> |
|---|---|
| <p><b>Remarks</b><br/>(L) Front Seat - Worn - Yes / (R) Front Trim - Grime - Minimal / (L) Front Trim - Grime - Minimal / Ceiling - Grime - Small</p> | <p><b>Remarks</b><br/>(R) Front Fender, Molding - Scratch - Small / (R) Front Door, Molding - Scratch - Small / (R) Rear Door, Molding - Scratch - Minimal / (R) Rear Fender, Molding - Scratch - Small / Rear Bumper, Lamps, Panels - Scratch &amp; Dent - Large / Trunk Hood, Rear Gate - Crack, Gap - Medium / (L) Rear Fender, Molding - Scratch - Small / (L) Rear Door, Molding - Scratch - Small / (L) Front Door, Molding - Scratch - Small / (L) Mirror - Scratch - Minimal / (L) Front Fender, Molding - Scratch - Minimal / Front Bumper, Grille, Lamps - Scratch - Minimal / Bonnet, Headlight - Scratch - Small / Roof - Scratch - Minimal</p> |

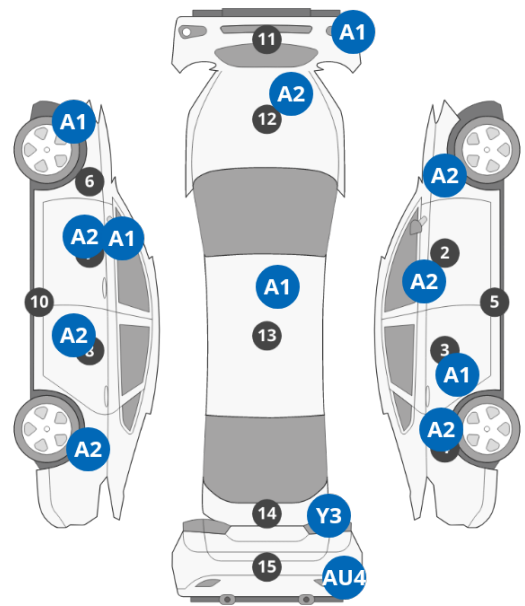
no warranty booklet, with jack and tools, with spare tire, with LTO plate, scratched and cracked tail light,
