## General Information

| Make | Toyota | Model | Vios |
| Registration No. | DAQ1329 | Chassis No. | PA1B18F3XN4172479 |

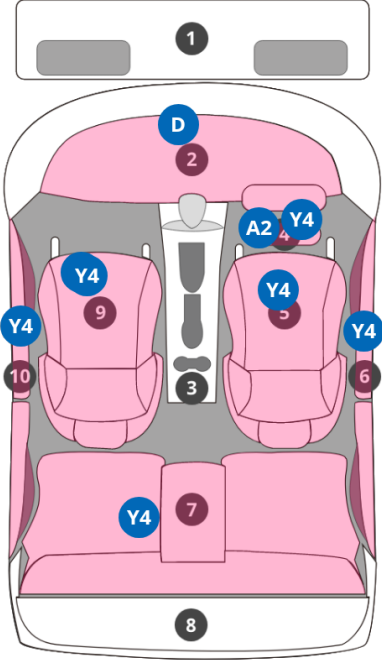
| Interior Evaluation : <span>E</span> | Exterior Evaluation : <span>E</span> |
|---|---|
| <p><b>Remarks</b></p> <p>Overall Interior - Smell - Yes / (L) Front Seat - Grime - Large / (L) Front Floor Mat - Cut, Crack - Small / Dashboard - Traces of Adhesive Tape - Yes / (R) Front Seat - Grime - Large / Rear Seat - Grime - Large / Mat Other - Grime - Large / (R) Front Trim - Grime - Large / (L) Front Trim - Grime - Large</p> | <p><b>Remarks</b></p> <p>(R) Front Door - Repair Traces - Yes / (R) Step - Repair Traces - Yes / (R) Front Fender - Repair Traces - Yes / (L) Step - Repair Traces - Yes / (L) Rear Fender - Repair Traces - Yes / Rear Bumper, Lamps, Panels - Scratch &amp; Dent - Large / (R) Rear Fender, Molding - Scratch &amp; Dent - Medium / (R) Rear Door, Molding - Scratch &amp; Dent - Large / (R) Front Door, Molding - Scratch &amp; Dent - Large / (R) Front Fender, Molding - Scratch &amp; Dent - Medium / Front Bumper, Grille, Lamps - Scratch &amp; Dent - Large / Member (Bolted) - Dent - Yes / (L) Front Fender, Molding - Scratch &amp; Dent - Small / Bonnet, Headlight - Scratch - Large / (L) Front Door, Molding - Scratch &amp; Dent - Medium / (L) Front Door, Molding - Repair mark - Difference in Color / (L) Rear Door, Molding - Scratch &amp; Dent - Large / (L) Rear Fender, Molding - Scratch &amp; Dent - Small / Trunk Hood, Rear Gate - Scratch &amp; Dent - Large</p> |
