## General Information

| Make | Toyota | Model | Vios |
| Registration No. | EAI8700 | Chassis No. | PA1B18F31P4222057 |

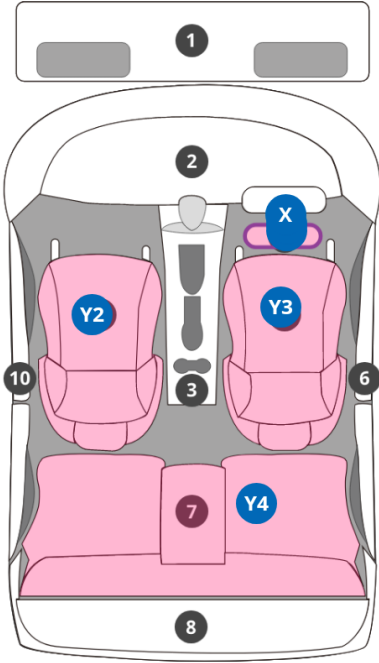
| Interior Evaluation : <span style="color: red;">C</span> | Exterior Evaluation : <span style="color: red;">D</span> |
| <b>Remarks</b><br>(R) Front Floor Mat - Missing - Yes / (L) Front Floor Mat - Missing - Yes / Mat Other - Missing - Yes / Rear Seat - Grime - Large / (R) Front Seat - Grime - Medium / (L) Front Seat - Grime - Small | <b>Remarks</b><br>(R) Front Fender, Molding - Scratch - Small / (R) Mirror - Scratch - Small / (R) Front Door, Molding - Scratch - Small / (R) Rear Door, Molding - Scratch - Small / (R) Rear Fender, Molding - Scratch - Medium / Rear Bumper, Lamps, Panels - Scratch - Small / Trunk Hood, Rear Gate - Scratch - Minimal / (L) Rear Fender, Molding - Scratch - Minimal / (L) Rear Door, Molding - Scratch - Small / (L) Front Door, Molding - Scratch - Small / (L) Front Fender, Molding - Dent - Large / Front Bumper, Grille, Lamps - Scratch - Medium / Bonnet, Headlight - Scratch & Dent - Medium / Roof - Scratch - Minimal |

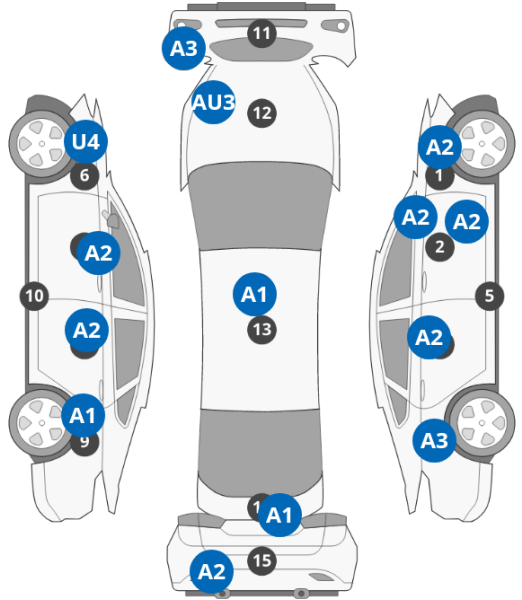
| Inspector Notes |
|---|
| with LTO plate, no warranty booklet, no jack and tools, with spare tire, with key , engine won't start, functional and mileage can not be verified due to remote key is not working, damaged tail light and headlights |
