## General Information

| Make | Toyota | Model | Fortuner |
| YOM | 2022 | Odo Meter Reading | 69,460 |

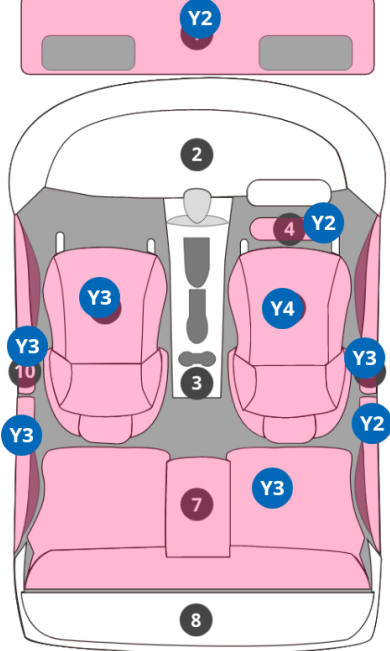
| Interior Evaluation : <span style="color: red; font-weight: bold;">D</span> | Exterior Evaluation : <span style="color: red; font-weight: bold;">D</span> |
| <p><b>Remarks</b></p> <p>Ceiling - Grime - Small / (R) Front Trim - Grime - Medium / (R) Front Seat - Grime - Large / (R) Front Floor Mat - Grime - Small / Rear Seat - Grime - Medium / (R) Rear Trim - Grime - Small / (L) Rear Trim - Grime - Medium / (L) Front Trim - Grime - Medium / (L) Front Seat - Grime - Medium</p> | <p><b>Remarks</b></p> <p>(L) Rear Door, Molding - Scratch &amp; Dent - Medium / (L) Front Door, Molding - Scratch - Minimal / (L) Front Fender, Molding - Scratch - Small / Bonnet, Headlight - Dent - Small / Front Bumper, Grille, Lamps - Scratch &amp; Dent - Small / (R) Front Fender, Molding - Scratch - Large / (R) Step, In-panel, Side Spoiler - Scratch &amp; Dent - Medium / (R) Front Door, Molding - Scratch - Small / (R) Rear Door, Molding - Scratch - Minimal / (R) Rear Fender, Molding - Scratch - Minimal / Trunk Hood, Rear Gate - Scratch &amp; Dent - Small / (L) Rear Fender, Molding - Scratch - Minimal / Rear Bumper, Lamps, Panels - Scratch &amp; Dent - Medium</p> |
