General Information

Make	Toyota	Model	Vios
YOM	2024	Odo Meter Reading	38,622
Registration No.	NFR5345	Chassis No.	PA1B18F31R4252081
CC	1.3	Transmission	CVT
Fuel Type	Gas	Type of Body	Sedan
Colour	Black

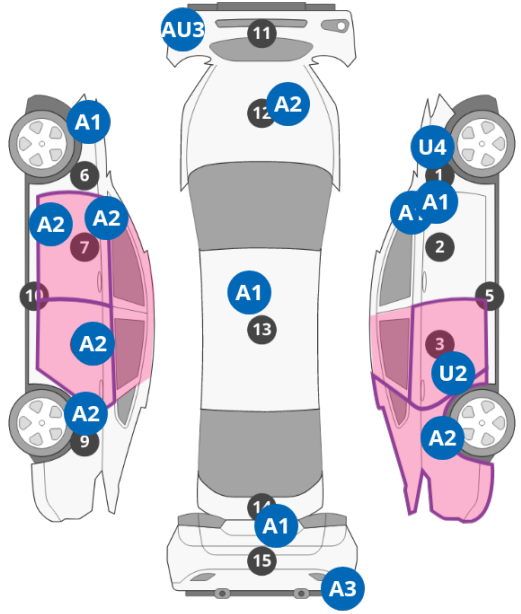
Interior Evaluation :	C	Exterior Evaluation :	E

<p>a : Cut, Fray d : Loose, Deformed k : Animal Hair s : Smell t : Cigarette Burns x : Defective y : Stain</p>		<p>A : Scratch AU : Scratch & Dent B : Modified C : Corrosion G : Stone chip P : Faded S : Rust SC : Rust & Corrosion U : Dent X : Defective Y : Crack, Gap</p>	
<p>Remarks Trunk Room - Worn, Scratch, Cut, Crack - Small / Rear Seat - Grime - Medium / (L) Front Floor Mat - Worked - Large / (L) Front Seat - Grime - Small / Ceiling - Grime - Large / (R) Front Seat - Grime - Medium / Console, Switches, Vents - Worn, Scratch, Cut, Crack - Small</p>		<p>Remarks (R) Rear Fender, Molding - Repair mark - Yes / (R) Rear Door, Molding - Repair mark - Yes / (R) Front Fender, Molding - Dent - Large / (R) Mirror - Scratch - Minimal / (R) Front Door, Molding - Scratch - Minimal / (R) Rear Door, Molding - Dent - Small / (R) Rear Fender, Molding - Scratch - Small / Rear Bumper, Lamps, Panels - Scratch - Medium / Trunk Hood, Rear Gate - Scratch - Minimal / (L) Front Door, Molding - Repair mark - Yes / (L) Rear Fender, Molding - Scratch - Small / (L) Rear Door, Molding - Scratch - Small / (L) Front Door, Molding - Scratch - Small / (L) Rear Door, Molding - Repair mark - Yes / (L) Mirror - Scratch - Small / (L) Front Fender, Molding - Scratch - Minimal / Front Bumper, Grille, Lamps - Scratch & Dent - Medium / Bonnet, Headlight - Scratch - Small / Roof - Scratch - Minimal</p>

Frame Evaluation :	D	Functional Evaluation :	A
<p>Remarks Right Front Inside (Rear Side) - Traces of Bending, or Marks of Panel Repair ? - Yes</p>		<p>Remarks Spare Key - Issue - Unexist</p>

Inspector Notes
with LTO plate, with warranty booklet, with jack and incomplete tools, with spare tire, scratches on tail light, traces of adhesive on front windshield
