## General Information

| Make | Toyota | Model | Hilux |
| YOM | 2021 | Odo Meter Reading | 156,128 |

## Body / Panel Condition

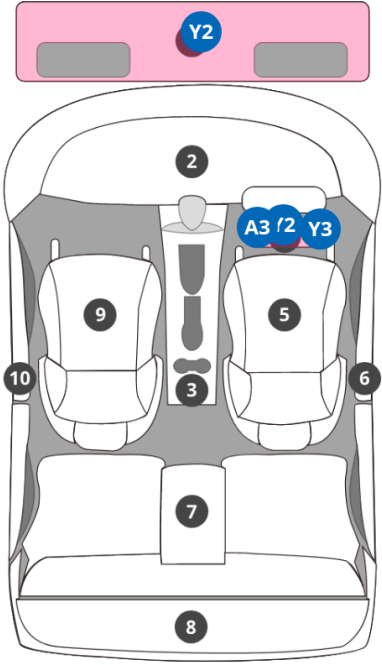
| Interior Evaluation : <b>B</b> | Exterior Evaluation : <b>E</b> |
| <b>Remarks</b><br>Ceiling - Grime - Small / (R) Front Floor Mat - Grime - Medium / Mat Other - Grime - Small / (L) Front Floor Mat - Cut, Crack - Medium | <b>Remarks</b><br>(L) Front Door, Molding - Scratch & Dent - Minimal / (L) Rear Corner Panel - Scratch - Small / (L) Rear Door, Molding - Scratch - Small / Bonnet, Headlight - Dent - Small / (R) Rear Door, Molding - Scratch - Medium / (R) Front Door, Molding - Scratch - Small / (R) Step, In-panel, Side Spoiler - Scratch & Dent - Large / Front Bumper, Grille, Lamps - Scratch & Dent - Large / Rear Gate - Scratch - Medium / (R) Side Gate - Scratch & Dent - Large / (L) Side Gate - Scratch - Large / (L) Guard Frame - Scratch & Dent - Large / (R) Guard Frame - Scratch & Dent - Large / Rear Bumper, Lamps, Panels - Scratch - Medium / Roof - Dent - Minimal |
