## General Information

| Make | Toyota | Model | Vios |
| Registration No. | NGU1654 | Chassis No. | PA1B18F33M4133814 |

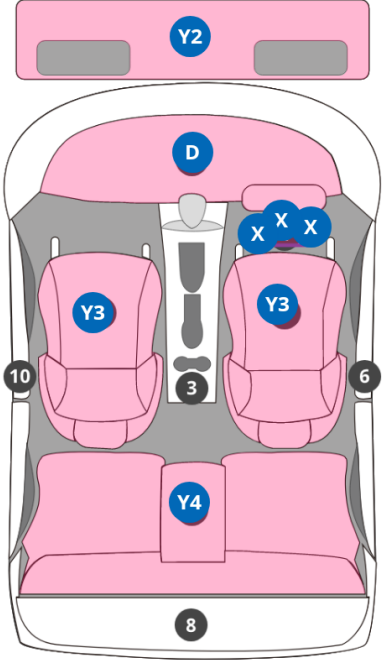
| Interior Evaluation : <span style="color: red;">C</span> | Exterior Evaluation : <span style="color: red;">C</span> |
| <b>Remarks</b><br>(R) Front Floor Mat - Missing - Yes / Mat Other - Missing - Yes / (L) Front Floor Mat - Missing - Yes / Dashboard - Traces of Adhesive Tape - Yes / (R) Front Seat - Grime - Medium / Rear Seat - Grime - Large / (L) Front Seat - Grime - Medium / Ceiling - Grime - Small | <b>Remarks</b><br>(R) Rear Door, Molding - Scratch - Medium / (R) Mirror - Scratch - Small / (R) Rear Fender, Molding - Scratch - Small / (L) Rear Fender, Molding - Dent - Small / (L) Rear Door, Molding - Scratch - Small / (L) Front Fender, Molding - Scratch - Minimal / (L) Step, In-panel, Side Spoiler - Scratch & Dent - Large / Front Bumper, Grille, Lamps - Scratch & Dent - Small / (R) Front Fender, Molding - Scratch - Small / Rear Bumper, Lamps, Panels - Scratch - Small / Trunk Hood, Rear Gate - Scratch & Dent - Small |
