## General Information

| Make | Toyota | Model | Vios |
| Registration No. | NIH2672 | Chassis No. | PA1B18F35N4199296 |

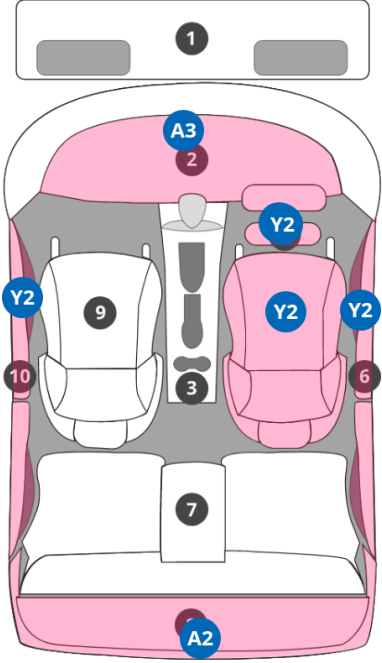
| Interior Evaluation : <b>B</b> | Exterior Evaluation : <b>D</b> |
| <b>Remarks</b><br>Mat Other - Grime - Medium / (R) Front Seat - Grime - Small / (R) Front Trim - Grime - Small / Trunk Room - Worn, Scratch, Cut, Crack - Small / (L) Front Trim - Grime - Small / (L) Front Floor Mat - Grime - Small / Dashboard - Worn, Scratch, Cut, Crack - Medium | <b>Remarks</b><br>Member (Bolted) - Dent - Yes / Bonnet, Headlight - Dent - Medium / Front Bumper, Grille, Lamps - Crack, Gap - Medium / (L) Front Fender, Molding - Scratch - Minimal / Trunk Hood, Rear Gate - Scratch & Dent - Small / Rear Bumper, Lamps, Panels - Scratch - Large / (L) Rear Fender, Molding - Scratch - Minimal / (L) Rear Door, Molding - Scratch - Small / (L) Front Door, Molding - Scratch - Small / (R) Front Door, Molding - Dent - Medium / (R) Front Fender, Molding - Scratch - Small / (R) Rear Door, Molding - Scratch - Medium / (R) Rear Fender, Molding - Scratch - Minimal / Roof - Scratch - Small |

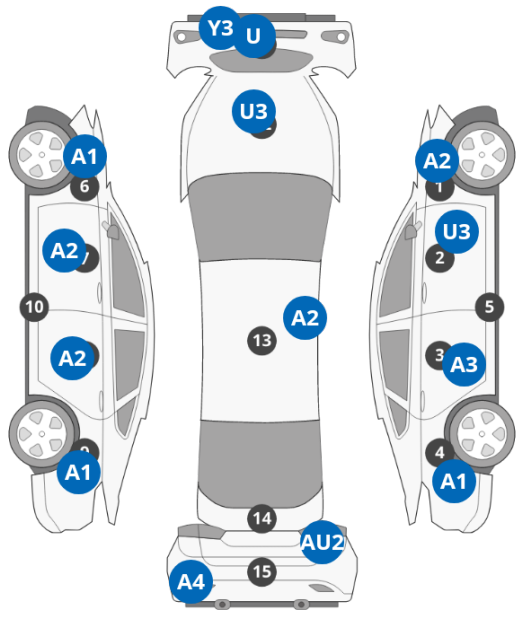
| Inspector Notes |
|---|
| with LTO plate/with spare tire/with jack and tools/No spare key/Left side tail lights housing crack/ reverse camera not working/with warranty booklet |
