## General Information

| Make | Toyota | Model | Innova |
| Registration No. | NIP3260 | Chassis No. | PA2JA8EM9P0126114 |

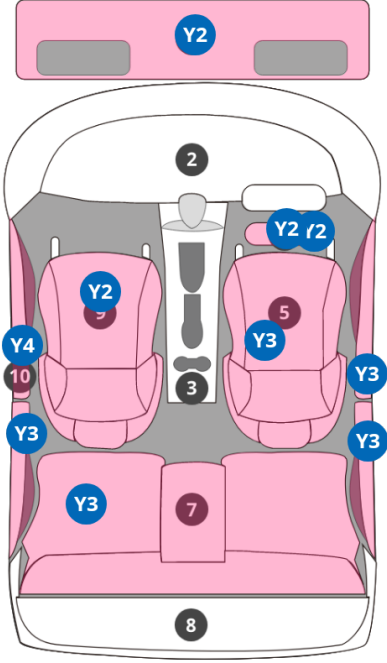
| Interior Evaluation : <b>D</b> | Exterior Evaluation : <b>E</b> |
|---|---|
| <p><b>Remarks</b></p> <p>Ceiling - Grime - Small / (R) Front Trim - Grime - Medium / (R) Front Floor Mat - Grime - Small / (R) Front Seat - Grime - Medium / (R) Rear Trim - Grime - Medium / Mat Other - Grime - Small / (L) Rear Trim - Grime - Medium / Rear Seat - Grime - Medium / (L) Front Trim - Grime - Large / (L) Front Seat - Grime - Small</p> | <p><b>Remarks</b></p> <p>(L) Front Fender - Repair Traces - Yes / (R) Rear Door - Repair Traces - Yes / Roof Spoiler, Molding - Crack, Gap - Large / Trunk Hood, Rear Gate - Scratch &amp; Dent - Large / Rear Bumper, Lamps, Panels - Scratch &amp; Dent - Large / Rear Windshield - Damaged - Large / (L) Rear Fender, Molding - Scratch &amp; Dent - Large / (L) Rear Door, Molding - Scratch - Small / (L) Front Door, Molding - Scratch - Small / (L) Mirror - Scratch - Minimal / (L) Front Fender, Molding - Scratch - Minimal / Front Bumper, Grille, Lamps - Scratch &amp; Dent - Large / (R) Front Fender, Molding - Scratch - Small / (R) Mirror - Scratch - Minimal / (R) Front Door, Molding - Scratch - Medium / (R) Rear Door, Molding - Scratch - Minimal / (R) Rear Fender, Molding - Scratch - Medium / Bonnet, Headlight - Scratch - Small</p> |

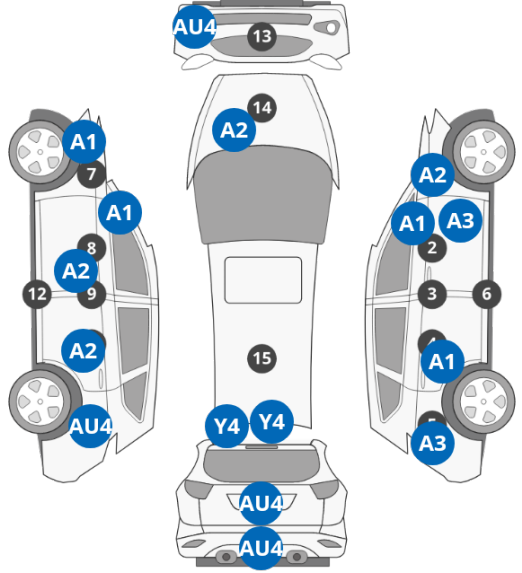
| Inspector Notes |
|---|
| <p>Damaged Rear Windshield, rear bumper, trunk door, roof spoiler and rear left fender. Low battery. Crack taillight. Taillight and hazard lights issue. Cannot confirm if with Jack and tools due of cannot open trunk door. With warranty booklet and spare tire. 2 keys. With LTO plate.</p> |
