## General Information

| Make | Toyota | Model | Vios |

## Body / Panel Condition

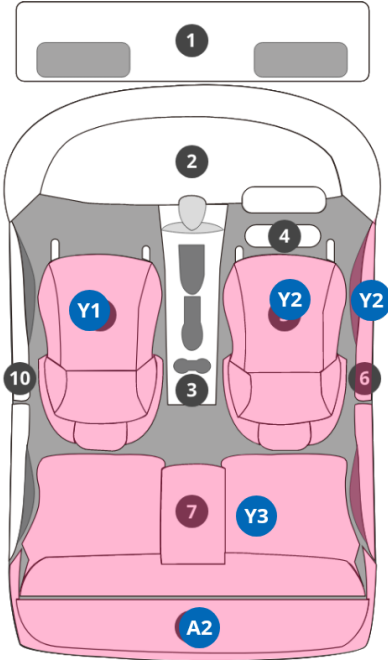
| Interior Evaluation : <b>B</b> | Exterior Evaluation : <b>C</b> |
| <b>Remarks</b><br>(R) Front Seat - Grime - Small / Trunk Room - Worn, Scratch, Cut, Crack - Small / Rear Seat - Grime - Medium / (R) Front Trim - Grime - Small / (L) Front Seat - Grime - Minimal | <b>Remarks</b><br>(L) Rear Door, Molding - Dent - Small / Bonnet, Headlight - Scratch - Medium / (L) Front Fender, Molding - Scratch - Medium / Front Bumper, Grille, Lamps - Scratch - Medium / (L) Front Door, Molding - Scratch - Minimal / Trunk Hood, Rear Gate - Scratch - Small / Rear Bumper, Lamps, Panels - Scratch - Minimal / (R) Rear Fender, Molding - Scratch - Minimal / (R) Rear Door, Molding - Scratch - Minimal / (R) Front Door, Molding - Scratch - Minimal / (R) Front Fender, Molding - Scratch - Small / Roof - Scratch - Minimal |
