## General Information

| Make | Toyota | Model | Wigo |
| Registration No. | DBM5583 | Chassis No. | MHKAA1BC4RJ015208 |

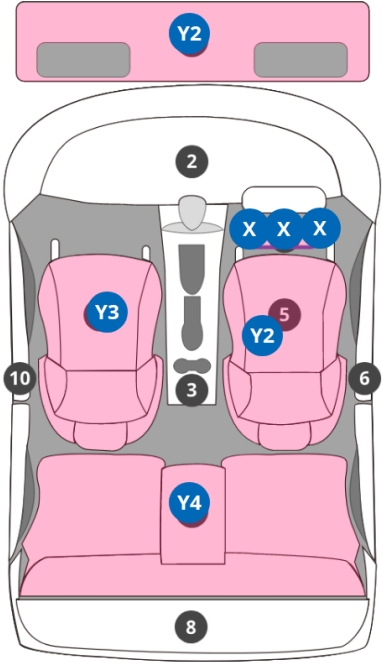
| Interior Evaluation : <b>C</b> | Exterior Evaluation : <b>C</b> |
|---|---|
| <p><b>Remarks</b><br/>Ceiling - Grime - Small / (R) Front Floor Mat - Missing - Yes / Mat Other - Missing - Yes / (L) Front Floor Mat - Missing - Yes / (R) Front Seat - Grime - Small / Rear Seat - Grime - Large / (L) Front Seat - Grime - Medium</p> | <p><b>Remarks</b><br/>Bonnet - Repair Traces - Yes / (R) Rear Door - Repair Traces - Yes / (R) Front Fender, Molding - Scratch - Small / (R) Rear Fender, Molding - Scratch - Medium / (L) Rear Fender, Molding - Scratch - Minimal / (L) Mirror - Scratch - Small / (L) Rear Door, Molding - Scratch - Small / (L) Front Fender, Molding - Scratch - Minimal / Front Bumper, Grille, Lamps - Scratch &amp; Dent - Large / Roof - Scratch &amp; Dent - Small</p> |

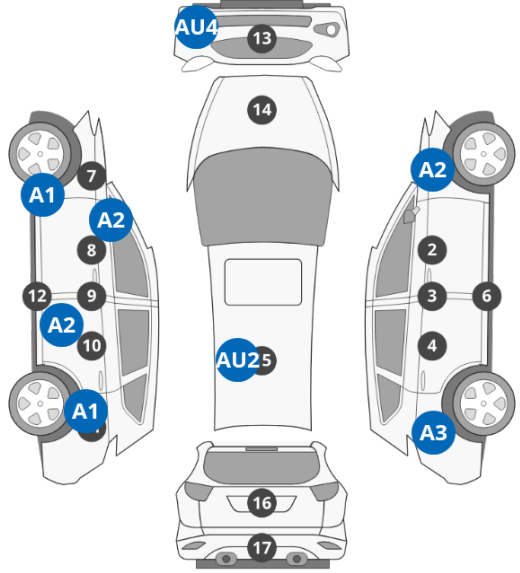
| Interior Evaluation : <b>C</b> | Exterior Evaluation : <b>C</b> |
|---|---|
| <p><b>a</b> : Cut, Fray <b>d</b> : Loose, Deformed <b>k</b> : Animal Hair <b>s</b> : Smell <b>t</b> : Cigarette Burns <b>x</b> : Defective <b>y</b> : Stain</p> | <p><b>A</b> : Scratch <b>AU</b> : Scratch &amp; Dent <b>B</b> : Modified <b>C</b> : Corrosion <b>G</b> : Stone chip <b>P</b> : Faded <b>S</b> : Rust <b>SC</b> : Rust &amp; Corrosion <b>U</b> : Dent <b>X</b> : Defective <b>Y</b> : Crack, Gap</p> |
