General Information

Make	Toyota	Model	Vios
YOM	2024	Odo Meter Reading	24,679
Registration No.	NKA3696-1	Chassis No.	PA1B183XR4245971
CC	1.3	Transmission	CVT
Fuel Type	Gas	Type of Body	Sedan
Colour	Red

Body / Panel Condition

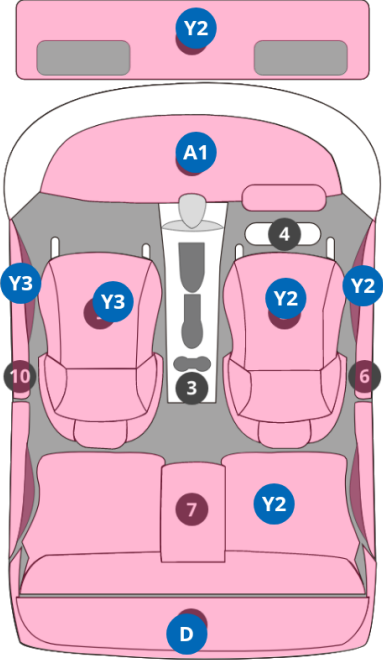
Interior Evaluation : B	Exterior Evaluation : C

<p>a : Cut, Fray d : Loose, Deformed k : Animal Hair s : Smell t : Cigarette Burns x : Defective y : Stain</p>

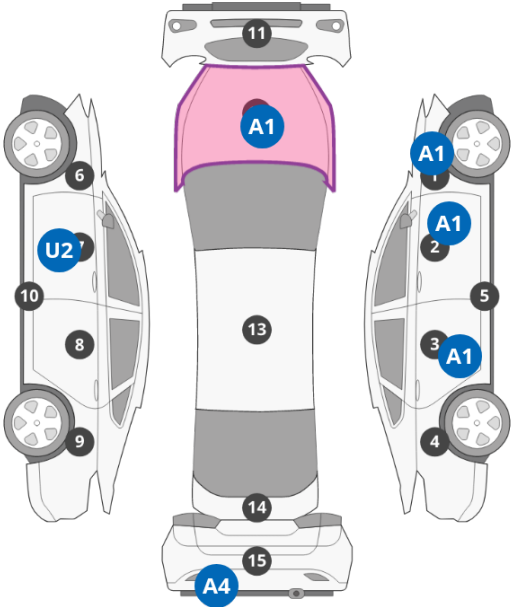
<p>A : Scratch AU : Scratch & Dent B : Modified C : Corrosion G : Stone chip P : Faded S : Rust SC : Rust & Corrosion U : Dent X : Defective Y : Crack, Gap</p>
Remarks Rear Seat - Grime - Small / (R) Front Seat - Grime - Small / (R) Front Trim - Grime - Small / Trunk Room - Traces of Adhesive Tape - Yes / (L) Front Seat - Grime - Medium / (L) Front Trim - Grime - Medium / Ceiling - Grime - Small	Remarks (R) Front Fender - Repair Traces - Yes / Bonnet - Repair Traces - Yes / (L) Front Fender - Repair Traces - Yes / Bonnet, Headlight - Repair mark - Yes / (R) Front Fender, Molding - Scratch - Minimal / (R) Front Door, Molding - Scratch - Minimal / (R) Rear Door, Molding - Scratch - Minimal / Rear Bumper, Lamps, Panels - Scratch - Large / (L) Front Door, Molding - Dent - Small / Bonnet, Headlight - Scratch - Minimal
