## General Information

<b>Make</b>	Nissan	<b>Model</b>	Terra
<b>YOM</b>	2019	<b>Odo Meter Reading</b>	65,956
<b>Registration No.</b>	GAL3356	<b>Chassis No.</b>	MNTJCAD23Z0005687
<b>CC</b>	2.5	<b>Transmission</b>	A/T
<b>Fuel Type</b>	Diesel	<b>Type of Body</b>	Wagon
<b>Colour</b>	Red

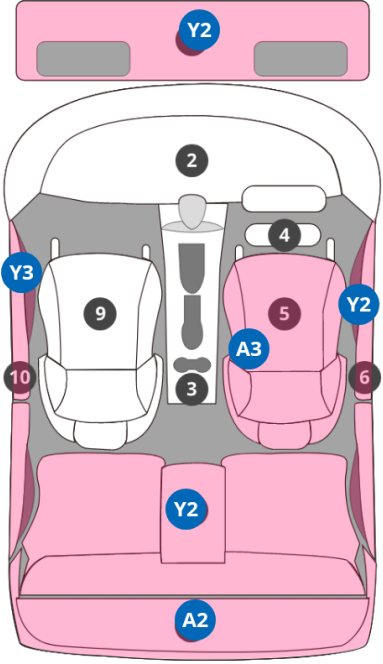
<b>Interior Evaluation :</b> <span style="float: right;"><b>B</b></span>	<b>Exterior Evaluation :</b> <span style="float: right;"><b>E</b></span>

<p><b>a</b> : Cut, Fray <b>d</b> : Loose, Deformed <b>k</b> : Animal Hair <b>s</b> : Smell <b>t</b> : Cigarette Burns <b>x</b> : Defective <b>y</b> : Stain</p>

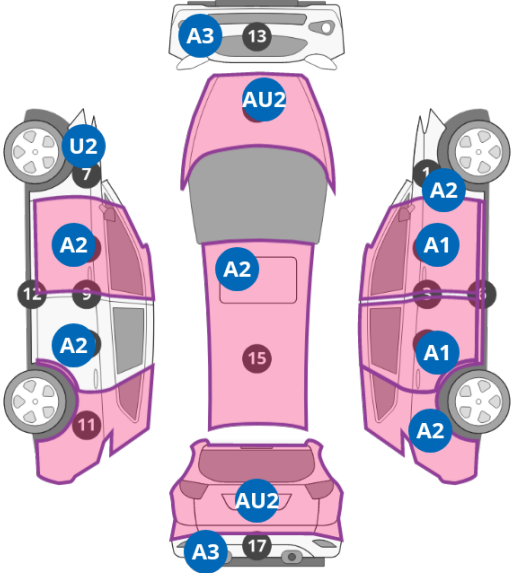
<p><b>A</b> : Scratch <b>AU</b> : Scratch &amp; Dent <b>B</b> : Modified <b>C</b> : Corrosion <b>G</b> : Stone chip <b>P</b> : Faded <b>S</b> : Rust <b>SC</b> : Rust &amp; Corrosion <b>U</b> : Dent <b>X</b> : Defective <b>Y</b> : Crack, Gap</p>
<p><b>Remarks</b> Rear Seat - Grime - Small / Trunk Room - Worn, Scratch, Cut, Crack - Small / (R) Front Trim - Grime - Small / (R) Front Seat - Cut, Crack - Medium / (L) Front Trim - Grime - Medium / Ceiling - Grime - Small</p>	<p><b>Remarks</b> (R) Front Door - Repair Traces - Yes / (R) Front Fender - Repair Traces - Yes / Bonnet - Repair Traces - Yes / (L) Front Fender - Repair Traces - Yes / (L) Rear Door - Repair Traces - Yes / (L) Rear Fender - Repair Traces - Yes / (R) Rear Fender - Repair Traces - Yes / (R) Rear Door - Repair Traces - Yes / Roof - Repair Traces - Yes / (R) Front Door, Molding - Repair mark - Yes / (R) Rear Door, Molding - Repair mark - Yes / (R) Rear Fender, Molding - Repair mark - Yes / Trunk Hood, Rear Gate - Repair mark - Yes / (L) Rear Fender, Molding - Repair mark - Yes / (L) Front Door, Molding - Repair mark - Yes / (L) Front Fender, Molding - Dent - Small / (L) Front Door, Molding - Scratch - Small / (L) Rear Door, Molding - Scratch - Small / Rear Bumper, Lamps, Panels - Scratch - Medium / Trunk Hood, Rear Gate - Scratch &amp; Dent - Small / (R) Rear Fender, Molding - Scratch - Small / (R) Step, In-panel, Side Spoiler - Partially Missing - Yes / (R) Front Fender, Molding - Scratch - Small / Bonnet, Headlight - Repair mark - Yes / (R) Front Door, Molding - Scratch - Minimal / (R) Rear Door, Molding - Scratch - Minimal / Bonnet, Headlight - Scratch &amp; Dent - Small / Front Bumper, Grille, Lamps - Scratch - Medium / Roof - Repair mark - Yes / Roof - Scratch - Small</p>
