General Information

Make	Toyota	Model	Hiace
YOM	2018	Odo Meter Reading	94,925
Registration No.	NCA5280	Chassis No.	JTFJT02P3H0008909
CC	3.0	Transmission	M/T
Fuel Type	Diesel	Type of Body	Van
Colour	White

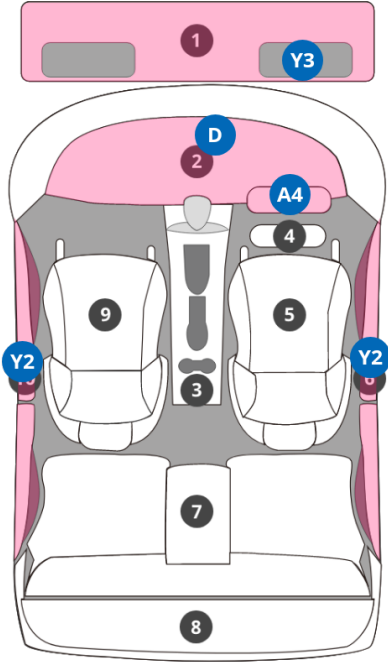
Interior Evaluation : C	Exterior Evaluation : C

<p>a : Cut, Fray d : Loose, Deformed k : Animal Hair s : Smell t : Cigarette Burns x : Defective y : Stain</p>

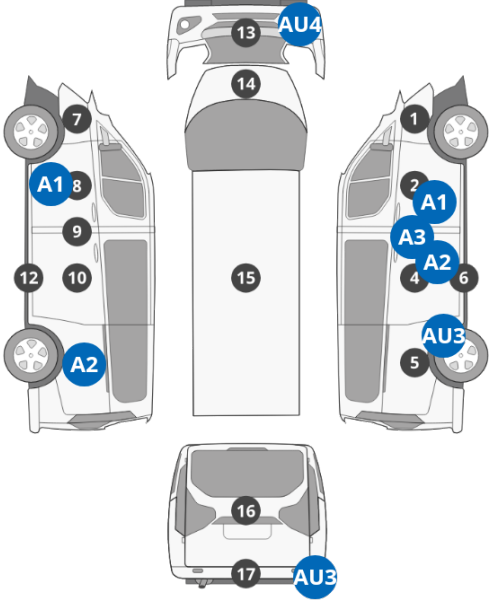
<p>A : Scratch AU : Scratch & Dent B : Modified C : Corrosion G : Stone chip P : Faded S : Rust SC : Rust & Corrosion U : Dent X : Defective Y : Crack, Gap</p>
<p>Remarks Dashboard - Traces of Adhesive Tape - Yes / Sunvisor, Sunglass Holder - Grime - Medium / (L) Front Trim - Grime - Small / (R) Front Trim - Grime - Small / Steering Wheel - Worn, Peel, Crack - Large</p>	<p>Remarks (R) Front Door - Repair Traces - Yes / (R) Step - Repair Traces - Yes / (R) Front Fender - Repair Traces - Yes / Bonnet - Repair Traces - Yes / (L) Front Fender - Repair Traces - Yes / (L) Front Door - Repair Traces - Yes / (L) Step - Repair Traces - Yes / (L) Rear Fender - Repair Traces - Yes / Trunk Hood, Rear Gate - Repair Traces - Yes / (R) Rear Fender - Repair Traces - Yes / (R) Rear Door - Repair Traces - Yes / Roof - Repair Traces - Yes / (R) Center Panel - Scratch - Medium / (R) Front Door, Molding - Scratch - Minimal / (R) Rear Door, Molding - Scratch - Small / (R) Rear Fender, Molding - Scratch & Dent - Medium / Rear Bumper, Lamps, Panels - Scratch & Dent - Medium / (L) Rear Fender, Molding - Scratch - Small / Front Bumper, Grille, Lamps - Scratch & Dent - Large / (L) Front Door, Molding - Scratch - Minimal</p>
