## General Information

<b>Make</b>	Toyota	<b>Model</b>	Vios
<b>YOM</b>	2025	<b>Odo Meter Reading</b>	30,317
<b>Registration No.</b>	NKJ8205	<b>Chassis No.</b>	PA1B8F3R4265635
<b>CC</b>	1.3	<b>Transmission</b>	CVT
<b>Fuel Type</b>	Gas	<b>Type of Body</b>	Sedan
<b>Colour</b>	Red

## Body / Panel Condition

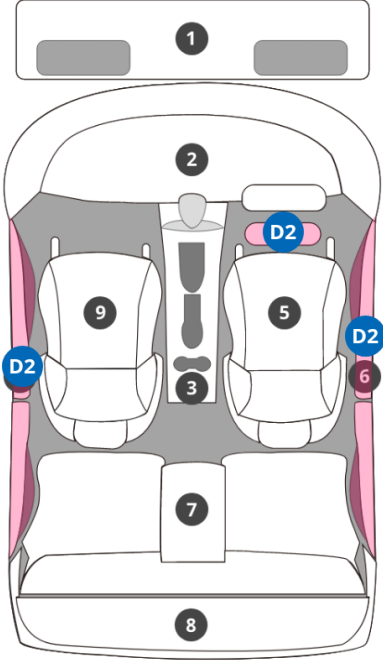
<b>Interior Evaluation :</b> <span style="color: red; font-weight: bold; font-size: 1.2em;">A</span>	<b>Exterior Evaluation :</b> <span style="color: red; font-weight: bold; font-size: 1.2em;">D</span>

<p><b>a</b> : Cut, Fray <b>d</b> : Loose, Deformed <b>k</b> : Animal Hair <b>s</b> : Smell <b>t</b> : Cigarette Burns <b>x</b> : Defective <b>y</b> : Stain</p>

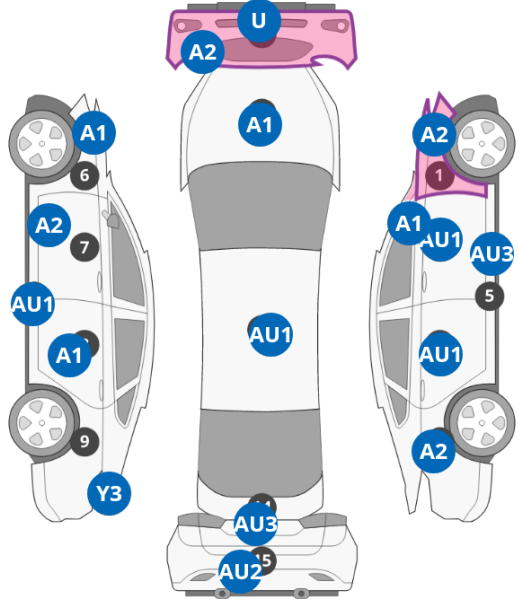
<p><b>A</b> : Scratch <b>AU</b> : Scratch &amp; Dent <b>B</b> : Modified <b>C</b> : Corrosion <b>G</b> : Stone chip <b>P</b> : Faded <b>S</b> : Rust <b>SC</b> : Rust &amp; Corrosion <b>U</b> : Dent <b>X</b> : Defective <b>Y</b> : Crack, Gap</p>
<p><b>Remarks</b> (L) Front Floor Mat - Worked - Small / (L) Front Trim - Worked - Small / (R) Front Trim - Worked - Small</p>	<p><b>Remarks</b> Member (Bolted) - Dent - Yes / Front Bumper, Grille, Lamps - Repair mark - Yes / Front Bumper, Grille, Lamps - Scratch - Small / (R) Front Fender, Molding - Repair mark - Yes / (R) Front Fender, Molding - Scratch - Small / (R) Step, In-panel, Side Spoiler - Scratch &amp; Dent - Medium / (R) Rear Door, Molding - Scratch &amp; Dent - Minimal / (R) Front Door, Molding - Scratch &amp; Dent - Minimal / (R) Rear Fender, Molding - Scratch - Small / (R) Mirror - Scratch - Minimal / Rear Bumper, Lamps, Panels - Scratch &amp; Dent - Small / Trunk Hood, Rear Gate - Scratch &amp; Dent - Medium / (L) Rear Door, Molding - Scratch - Minimal / (L) Front Door, Molding - Scratch - Small / (L) Step, In-panel, Side Spoiler - Scratch &amp; Dent - Minimal / (L) Front Fender, Molding - Scratch - Minimal / Bonnet, Headlight - Scratch - Minimal / Roof - Scratch &amp; Dent - Minimal / (L) Rear Fender, Molding - Crack, Gap - Medium</p>

<p><b>Inspector Notes</b></p>
<p>With LTO plate and Sparetire, Jack and Incomplete Tools. No warranty booklet and scratch headlight and tail light. adhesive marks on rear bumper.</p>
