## General Information

| Make | Toyota | Model | Hilux |
| YOM | 2022 | Odo Meter Reading | 41,320 |
| Registration No. | NFK7032 | Chassis No. | MR0JB8DD1N3191297 |

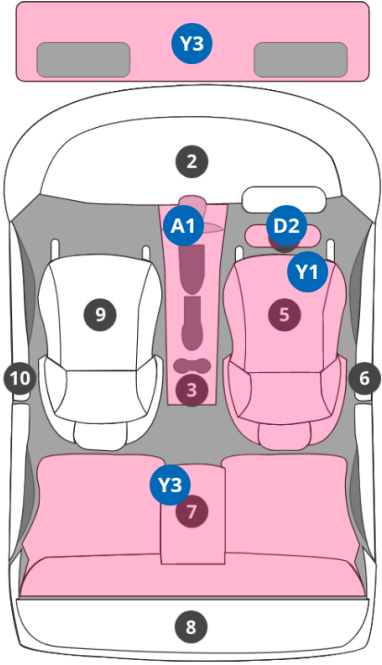
| Interior Evaluation : <span style="color: red;">C</span> | Exterior Evaluation : <span style="color: red;">E</span> |
| <b>Remarks</b><br>Rear Seat - Grime - Medium / Overall Interior - Worn as per age - Yes / (R) Front Seat - Grime - Minimal / (L) Front Floor Mat - Worked - Small / Console, Switches, Vents - Worn, Scratch, Cut, Crack - Minimal / Ceiling - Grime - Medium | <b>Remarks</b><br>(R) Step, In-panel, Side Spoiler - Dent - Medium / (R) Rear Door, Molding - Scratch & Dent - Small / (R) Front Door, Molding - Scratch & Dent - Small / (R) Side Gate - Scratch - Medium / Rear Gate - Scratch & Dent - Small / Rear Bumper, Lamps, Panels - Scratch - Small / (R) Front Fender, Molding - Scratch & Dent - Medium / Cargo Bed Floor - Modified - Large / (L) Side Gate - Scratch - Medium / (L) Rear Door, Molding - Scratch - Small / (L) Front Door, Molding - Scratch - Minimal / (L) Front Fender, Molding - Dent - Small / Front Bumper, Grille, Lamps - Scratch - Large / Roof - Scratch - Minimal / Bonnet, Headlight - Scratch - Small |

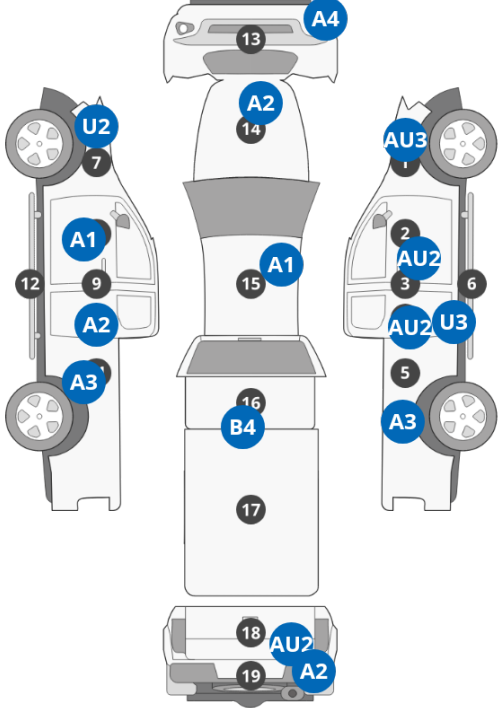
with LTO plate, no warranty booklet, with jack and incomplete tools, with spare tire, busted headlight and tail light, scratches on headlight and tail light, original spare tire is installed. Replacement (damaged).
