General Information

Make	Toyota	Model	Vios
YOM	2023	Odo Meter Reading	32,184
Registration No.	NII9810	Chassis No.	PA1B18F3XP4202650
CC	1.3	Transmission	CVT
Fuel Type	Gas	Type of Body	Sedan
Colour	Silver

Body / Panel Condition

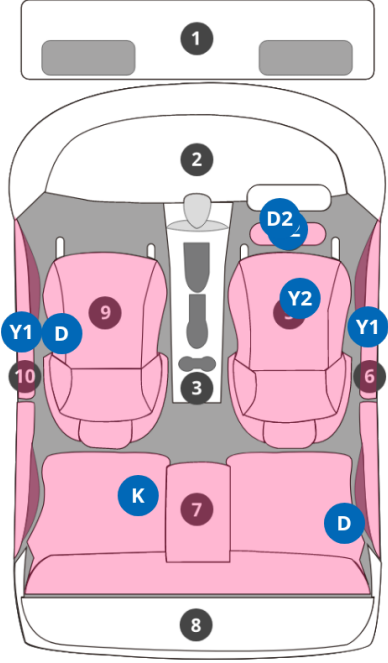
Interior Evaluation : B	Exterior Evaluation : E

<p>a : Cut, Fray d : Loose, Deformed k : Animal Hair s : Smell t : Cigarette Burns x : Defective y : Stain</p>

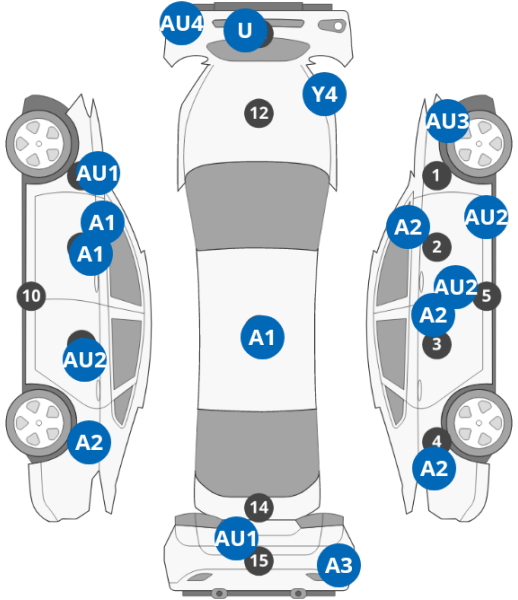
<p>A : Scratch AU : Scratch & Dent B : Modified C : Corrosion G : Stone chip P : Faded S : Rust SC : Rust & Corrosion U : Dent X : Defective Y : Crack, Gap</p>
<p>Remarks (R) Front Seat - Grime - Small / (L) Front Seat - Worn - Yes / Overall Interior - Animal Hair - Yes / Rear Seat - Worn - Yes / (R) Front Trim - Grime - Minimal / (L) Front Floor Mat - Cut, Crack - Small / (L) Front Floor Mat - Worked - Small / (L) Front Trim - Grime - Minimal</p>	<p>Remarks (R) Mirror - Scratch - Small / (R) Front Fender, Molding - Scratch & Dent - Medium / (R) Front Door, Molding - Scratch & Dent - Small / (R) Step, In-panel, Side Spoiler - Scratch & Dent - Small / (R) Rear Door, Molding - Scratch - Small / (R) Rear Fender, Molding - Scratch - Small / Rear Bumper, Lamps, Panels - Scratch - Medium / Trunk Hood, Rear Gate - Scratch & Dent - Minimal / (L) Rear Fender, Molding - Scratch - Small / (L) Rear Door, Molding - Scratch & Dent - Small / Member (Bolted) - Dent - Yes / (L) Front Door, Molding - Scratch - Minimal / (L) Mirror - Scratch - Minimal / (L) Front Fender, Molding - Scratch & Dent - Minimal / Front Bumper, Grille, Lamps - Scratch & Dent - Large / Bonnet, Headlight - Crack, Gap - Large / Roof - Scratch - Minimal</p>
