General Information

Make	Toyota	Model	Vios
YOM	2023	Odo Meter Reading	77,528
Registration No.	NIP2746	Chassis No.	PA1B18F35P4206668
CC	1.3	Transmission	CVT
Fuel Type	Gas	Type of Body	Sedan
Colour	Black

Body / Panel Condition

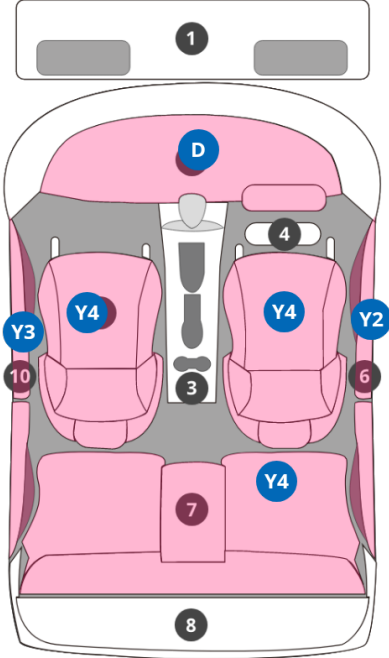
Interior Evaluation : C	Exterior Evaluation : E
<div style="text-align: center;">

</div> <p>a : Cut, Fray d : Loose, Deformed k : Animal Hair s : Smell t : Cigarette Burns x : Defective y : Stain</p>	<div style="text-align: center;">

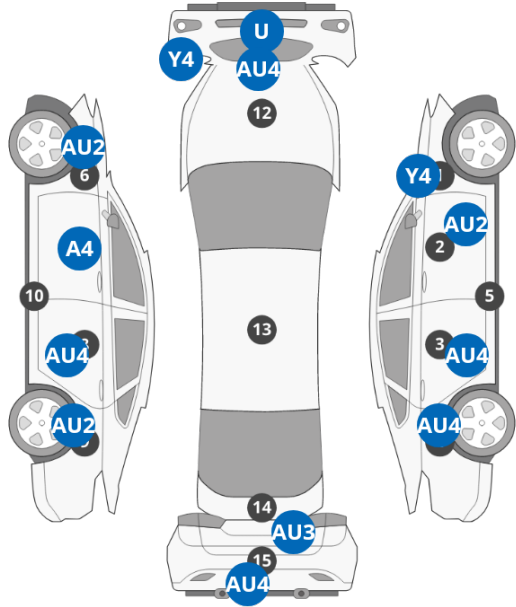
</div> <p>A : Scratch AU : Scratch & Dent B : Modified C : Corrosion G : Stone chip P : Faded S : Rust SC : Rust & Corrosion U : Dent X : Defective Y : Crack, Gap</p>
<p>Remarks Rear Seat - Grime - Large / (L) Front Seat - Grime - Large / (R) Front Seat - Grime - Large / (R) Front Trim - Grime - Small / Dashboard - Traces of Adhesive Tape - Yes / (L) Front Trim - Grime - Medium</p>	<p>Remarks (R) Step - Repair Traces - Yes / Bonnet - Repair Traces - Yes / (L) Front Fender - Repair Traces - Yes / (L) Front Door - Repair Traces - Yes / (L) Step - Repair Traces - Yes / Trunk Hood, Rear Gate - Repair Traces - Yes / Trunk Hood, Rear Gate - Scratch & Dent - Medium / Rear Bumper, Lamps, Panels - Scratch & Dent - Large / (R) Rear Fender, Molding - Scratch & Dent - Large / (R) Rear Door, Molding - Scratch & Dent - Large / (R) Front Door, Molding - Scratch & Dent - Small / (R) Front Fender, Molding - Crack, Gap - Large / Member (Bolted) - Dent - Yes / Bonnet, Headlight - Scratch & Dent - Large / Front Bumper, Grille, Lamps - Crack, Gap - Large / (L) Front Fender, Molding - Scratch & Dent - Small / (L) Front Door, Molding - Scratch & Dent - Large / (L) Rear Door, Molding - Scratch & Dent - Large / (L) Rear Fender, Molding - Scratch & Dent - Small</p>
