## General Information

<b>Make</b>	Toyota	<b>Model</b>	Vios
<b>YOM</b>	2024	<b>Odo Meter Reading</b>	59,958
<b>Registration No.</b>	NIQ8253	<b>Chassis No.</b>	PA1B18F31P4234225
<b>CC</b>	1.3	<b>Transmission</b>	CVT
<b>Fuel Type</b>	Gas	<b>Type of Body</b>	Sedan
<b>Colour</b>	Silver

## Body / Panel Condition

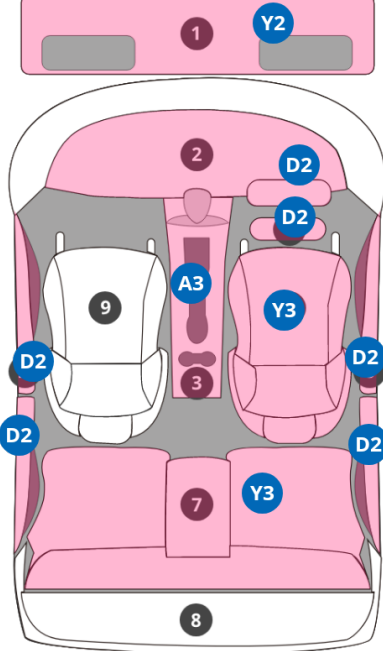
<b>Interior Evaluation :</b> <span style="float: right; color: red; font-weight: bold;">C</span>	<b>Exterior Evaluation :</b> <span style="float: right; color: red; font-weight: bold;">D</span>

<p><b>a</b> : Cut, Fray <b>d</b> : Loose, Deformed <b>k</b> : Animal Hair <b>s</b> : Smell <b>t</b> : Cigarette Burns <b>x</b> : Defective <b>y</b> : Stain</p>

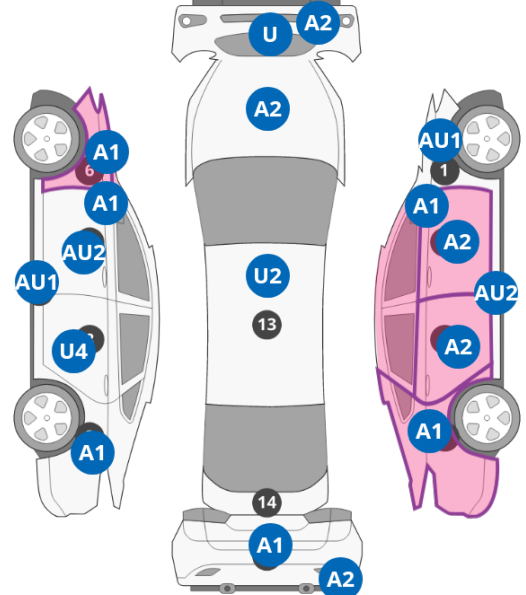
<p><b>A</b> : Scratch <b>AU</b> : Scratch &amp; Dent <b>B</b> : Modified <b>C</b> : Corrosion <b>G</b> : Stone chip <b>P</b> : Faded <b>S</b> : Rust <b>SC</b> : Rust &amp; Corrosion <b>U</b> : Dent <b>X</b> : Defective <b>Y</b> : Crack, Gap</p>
<p><b>Remarks</b> Rear Seat - Grime - Medium / (R) Front Seat - Grime - Medium / Glove Box - Loose, Deformed - Small / (L) Front Floor Mat - Worked - Small / (L) Front Trim - Worked - Small / (R) Front Trim - Worked - Small / (L) Rear Trim - Worked - Small / (R) Rear Trim - Worked - Small / Ceiling - Grime - Small / Knobs - Worn, Peel, Crack - Medium</p>	<p><b>Remarks</b> (R) Rear Door, Molding - Repair mark - Yes / (L) Front Fender, Molding - Repair mark - Yes / (R) Front Fender, Molding - Repair mark - Yes / (R) Front Door, Molding - Repair mark - Yes / (R) Front Door, Molding - Scratch - Small / (R) Rear Door, Molding - Scratch - Small / (R) Rear Fender, Molding - Scratch - Minimal / Trunk Hood, Rear Gate - Scratch - Minimal / Rear Bumper, Lamps, Panels - Scratch - Small / (L) Rear Fender, Molding - Scratch - Minimal / (R) Step, In-panel, Side Spoiler - Scratch &amp; Dent - Small / (L) Rear Door, Molding - Dent - Large / Member (Bolted) - Dent - Yes / (L) Front Door, Molding - Scratch &amp; Dent - Small / (L) Front Fender, Molding - Scratch - Minimal / (L) Mirror - Scratch - Minimal / (R) Mirror - Scratch - Minimal / Bonnet, Headlight - Scratch - Small / Front Bumper, Grille, Lamps - Scratch - Small / (R) Front Fender, Molding - Scratch &amp; Dent - Minimal / Roof - Dent - Small / (L) Step, In-panel, Side Spoiler - Scratch &amp; Dent - Minimal</p>
