General Information

Make	Toyota	Model	Vios
YOM	2024	Odo Meter Reading	11,937
Registration No.	DBN8177	Chassis No.	PA1B18F38P4234433
CC	1.3	Transmission	CVT
Fuel Type	Gas	Type of Body	Sedan
Colour	Red Mica Metallic

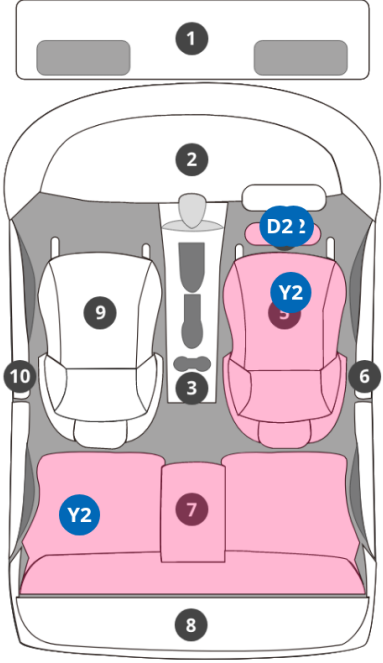
Interior Evaluation : A	Exterior Evaluation : C

<p>a : Cut, Fray d : Loose, Deformed k : Animal Hair s : Smell t : Cigarette Burns x : Defective y : Stain</p>

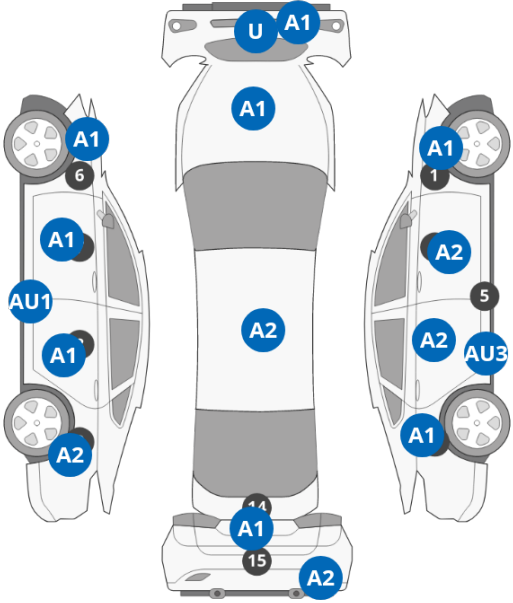
<p>A : Scratch AU : Scratch & Dent B : Modified C : Corrosion G : Stone chip P : Faded S : Rust SC : Rust & Corrosion U : Dent X : Defective Y : Crack, Gap</p>
<p>Remarks Rear Seat - Grime - Small / (R) Front Seat - Grime - Small / (R) Front Floor Mat - Grime - Small / (L) Front Floor Mat - Worked - Small</p>	<p>Remarks (R) Step, In-panel, Side Spoiler - Scratch & Dent - Medium / (R) Rear Fender, Molding - Scratch - Minimal / (R) Rear Door, Molding - Scratch - Small / (R) Front Door, Molding - Scratch - Small / (R) Front Fender, Molding - Scratch - Minimal / Rear Bumper, Lamps, Panels - Scratch - Small / Trunk Hood, Rear Gate - Scratch - Minimal / (L) Rear Fender, Molding - Scratch - Small / (L) Rear Door, Molding - Scratch - Minimal / (L) Step, In-panel, Side Spoiler - Scratch & Dent - Minimal / (L) Front Door, Molding - Scratch - Minimal / (L) Front Fender, Molding - Scratch - Minimal / Bonnet, Headlight - Scratch - Minimal / Roof - Scratch - Small / Member (Bolted) - Dent - Yes / Front Bumper, Grille, Lamps - Scratch - Minimal</p>
