General Information

Make	Toyota	Model	Vios
YOM	2024	Odo Meter Reading	122,541
Registration No.	DBO2338	Chassis No.	PA1B18F32P4238140
CC	1.3	Transmission	CVT
Fuel Type	Gas	Type of Body	Sedan
Colour	Black

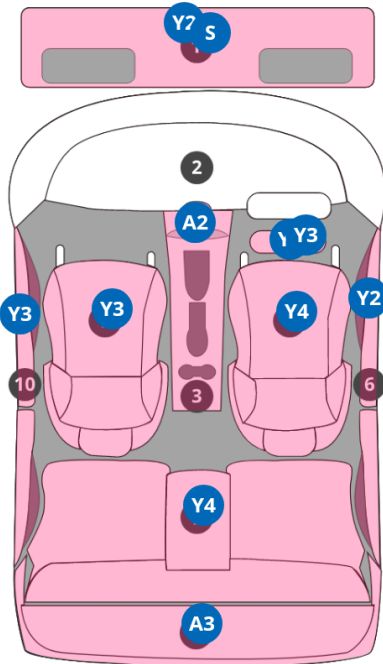
Interior Evaluation : E	Exterior Evaluation : E

<p>a : Cut, Fray d : Loose, Deformed k : Animal Hair s : Smell t : Cigarette Burns x : Defective y : Stain</p>

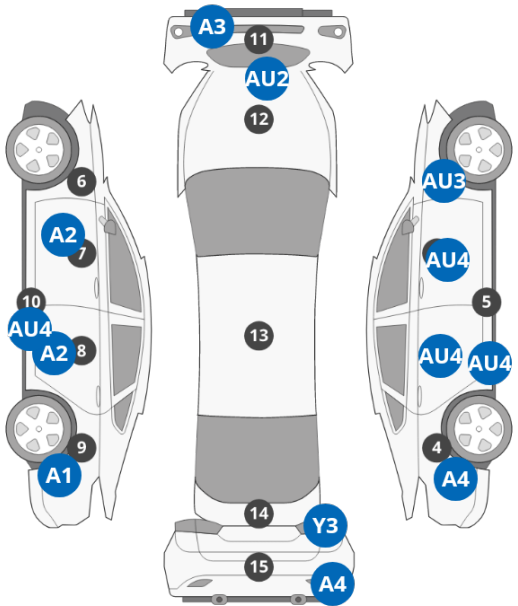
<p>A : Scratch AU : Scratch & Dent B : Modified C : Corrosion G : Stone chip P : Faded S : Rust SC : Rust & Corrosion U : Dent X : Defective Y : Crack, Gap</p>
<p>Remarks Trunk Room - Worn, Scratch, Cut, Crack - Medium / Rear Seat - Grime - Large / (R) Front Seat - Grime - Large / (R) Front Trim - Grime - Small / (R) Front Floor Mat - Grime - Medium / (L) Front Seat - Grime - Medium / (L) Front Floor Mat - Grime - Medium / (L) Front Trim - Grime - Medium / Ceiling - Grime - Small / Overall Interior - Smell - Yes / Knobs - Worn, Peel, Crack - Small</p>	<p>Remarks (R) Front Fender - Repair Traces - Yes / Rear Bumper, Lamps, Panels - Scratch - Large / (R) Rear Fender, Molding - Scratch - Large / (R) Front Door, Molding - Scratch & Dent - Large / (R) Step, In-panel, Side Spoiler - Scratch & Dent - Large / (R) Rear Door, Molding - Scratch & Dent - Large / (R) Front Fender, Molding - Scratch & Dent - Medium / Bonnet, Headlight - Scratch & Dent - Small / Front Bumper, Grille, Lamps - Scratch - Medium / (L) Front Door, Molding - Scratch - Small / (L) Rear Door, Molding - Scratch - Small / (L) Step, In-panel, Side Spoiler - Scratch & Dent - Large / (L) Rear Fender, Molding - Scratch - Minimal / Trunk Hood, Rear Gate - Crack, Gap - Medium</p>
