General Information

Make	Toyota	Model	Vios
YOM	2024	Odo Meter Reading	21,576
Registration No.	BAF9221	Chassis No.	PA1B18F36R4243652
CC	1.3	Transmission	CVT
Fuel Type	Gas	Type of Body	Sedan
Colour	Silver

Body / Panel Condition

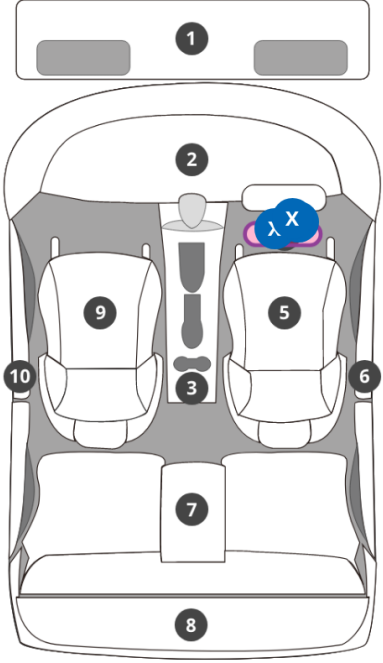
Interior Evaluation : B	Exterior Evaluation : B

<p>a : Cut, Fray d : Loose, Deformed k : Animal Hair s : Smell t : Cigarette Burns x : Defective y : Stain</p>

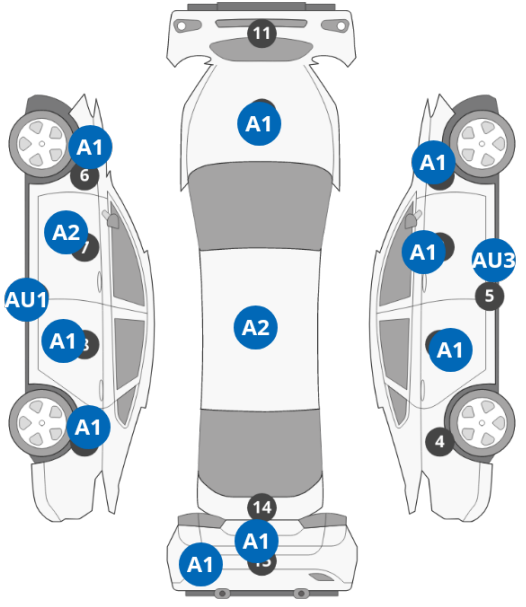
<p>A : Scratch AU : Scratch & Dent B : Modified C : Corrosion G : Stone chip P : Faded S : Rust SC : Rust & Corrosion U : Dent X : Defective Y : Crack, Gap</p>
<p>Remarks (L) Front Floor Mat - Missing - Yes / (R) Front Floor Mat - Missing - Yes / Mat Other - Missing - Yes</p>	<p>Remarks (R) Front Fender, Molding - Scratch - Minimal / (R) Step, In-panel, Side Spoiler - Scratch & Dent - Medium / (R) Front Door, Molding - Scratch - Minimal / (R) Rear Door, Molding - Scratch - Minimal / (L) Rear Fender, Molding - Scratch - Minimal / (L) Rear Door, Molding - Scratch - Minimal / (L) Step, In-panel, Side Spoiler - Scratch & Dent - Minimal / (L) Front Door, Molding - Scratch - Small / Bonnet, Headlight - Scratch - Minimal / Roof - Scratch - Small / Rear Bumper, Lamps, Panels - Scratch - Minimal / Trunk Hood, Rear Gate - Scratch - Minimal / (L) Front Fender, Molding - Scratch - Minimal</p>
