General Information

Make	Toyota	Model	Innova
YOM	2024	Odo Meter Reading	20,751
Registration No.	NHH6932	Chassis No.	PA2JA8EM0R0136556
CC	2.8	Transmission	A/T
Fuel Type	Diesel	Type of Body	Wagon
Colour	Red Mica Metallic

Body / Panel Condition

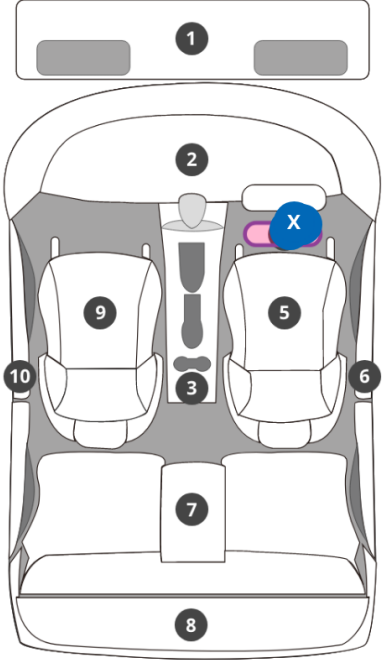
Interior Evaluation : B	Exterior Evaluation : B

<p>a : Cut, Fray d : Loose, Deformed k : Animal Hair s : Smell t : Cigarette Burns x : Defective y : Stain</p>

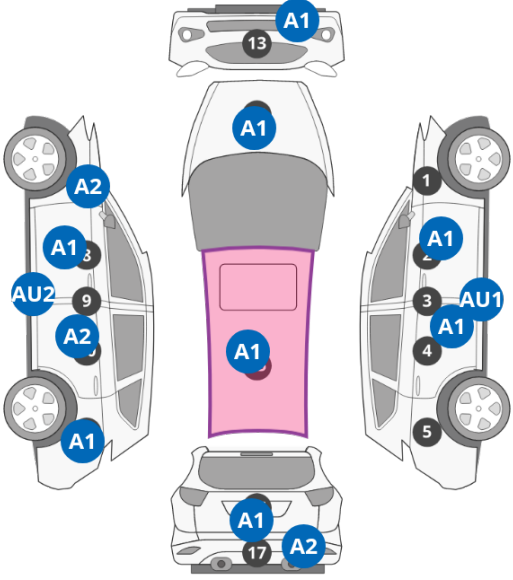
<p>A : Scratch AU : Scratch & Dent B : Modified C : Corrosion G : Stone chip P : Faded S : Rust SC : Rust & Corrosion U : Dent X : Defective Y : Crack, Gap</p>
<p>Remarks (L) Front Floor Mat - Missing - Yes / (R) Front Floor Mat - Missing - Yes / Mat Other - Missing - Yes</p>	<p>Remarks (L) Front Fender, Molding - Scratch - Small / (L) Step, In-panel, Side Spoiler - Scratch & Dent - Small / (L) Front Door, Molding - Scratch - Minimal / (L) Rear Door, Molding - Scratch - Small / (L) Rear Fender, Molding - Scratch - Minimal / (R) Front Door, Molding - Scratch - Minimal / (R) Rear Door, Molding - Scratch - Minimal / (R) Step, In-panel, Side Spoiler - Scratch & Dent - Minimal / Rear Bumper, Lamps, Panels - Scratch - Small / Trunk Hood, Rear Gate - Scratch - Minimal / Bonnet, Headlight - Scratch - Minimal / Front Bumper, Grille, Lamps - Scratch - Minimal / Roof - Scratch - Minimal / Roof Spoiler, Molding - Partially Missing - Yes</p>

<p>Inspector Notes</p>
<p>With LTO plate and warranty booklet and Sparetire, Incomplete Tools. No Jack, scratch headlight and tail light.</p>
