## General Information

<b>Make</b>	Toyota	<b>Model</b>	Yaris Cross
<b>YOM</b>	2023	<b>Odo Meter Reading</b>	20,356
<b>Registration No.</b>	CBI8516	<b>Chassis No.</b>	MHFAA8AF3P0005226
<b>CC</b>	1.5	<b>Transmission</b>	CVT
<b>Fuel Type</b>	Gas	<b>Type of Body</b>	SUV
<b>Colour</b>	Pearl White

## Body / Panel Condition

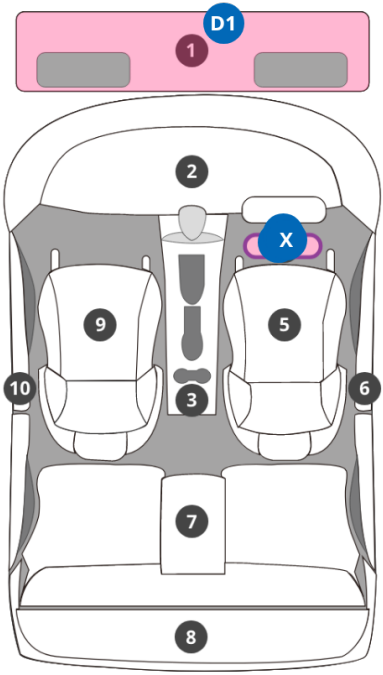
<b>Interior Evaluation :</b> <span style="float: right;"><b>B</b></span>	<b>Exterior Evaluation :</b> <span style="float: right;"><b>C</b></span>

<p><b>a</b> : Cut, Fray <b>d</b> : Loose, Deformed <b>k</b> : Animal Hair <b>s</b> : Smell <b>t</b> : Cigarette Burns <b>x</b> : Defective <b>y</b> : Stain</p>

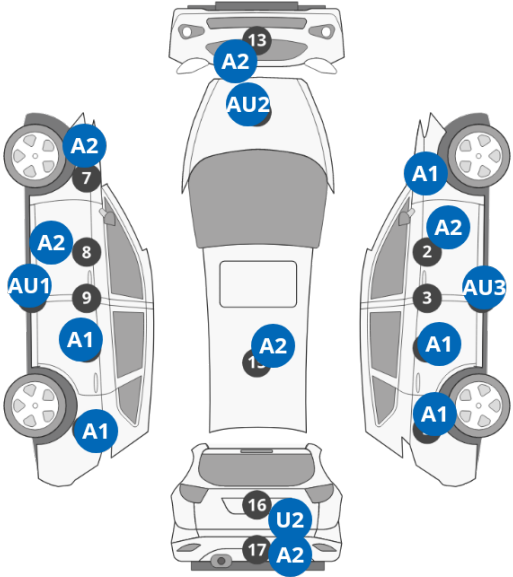
<p><b>A</b> : Scratch <b>AU</b> : Scratch &amp; Dent <b>B</b> : Modified <b>C</b> : Corrosion <b>G</b> : Stone chip <b>P</b> : Faded <b>S</b> : Rust <b>SC</b> : Rust &amp; Corrosion <b>U</b> : Dent <b>X</b> : Defective <b>Y</b> : Crack, Gap</p>
<p><b>Remarks</b> (L) Front Floor Mat - Missing - Yes / (R) Front Floor Mat - Missing - Yes / Mat Other - Missing - Yes / Ceiling - Crinkle - Minimal</p>	<p><b>Remarks</b> (L) Front Door, Molding - Scratch - Small / Front Bumper, Grille, Lamps - Scratch - Small / Bonnet, Headlight - Scratch &amp; Dent - Small / (R) Step, In-panel, Side Spoiler - Scratch &amp; Dent - Medium / (R) Front Door, Molding - Scratch - Small / Rear Bumper, Lamps, Panels - Scratch - Small / Trunk Hood, Rear Gate - Dent - Small / Roof - Scratch - Small / (L) Rear Door, Molding - Scratch - Minimal / (L) Rear Fender, Molding - Scratch - Minimal / (L) Front Fender, Molding - Scratch - Small / (L) Step, In-panel, Side Spoiler - Scratch &amp; Dent - Minimal / (R) Rear Door, Molding - Scratch - Minimal / (R) Front Fender, Molding - Scratch - Minimal / (R) Rear Fender, Molding - Scratch - Minimal</p>
