General Information

Make	Toyota	Model	Vios
YOM	2023	Odo Meter Reading	72,515
Registration No.	NIO2893	Chassis No.	PA1B18F35P4218190
CC	1.3	Transmission	CVT
Fuel Type	Gas	Type of Body	Sedan
Colour	Blue

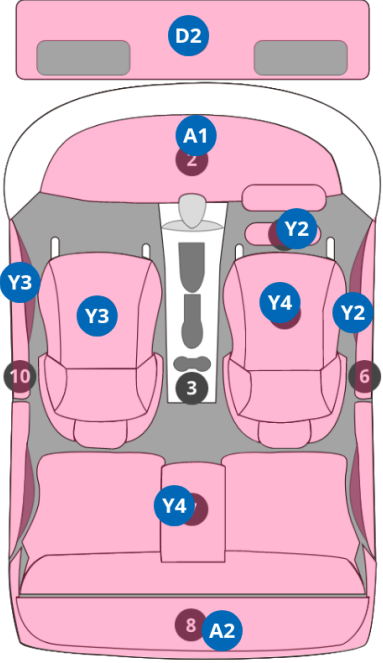
Interior Evaluation : C	Exterior Evaluation : C

<p>a : Cut, Fray d : Loose, Deformed k : Animal Hair s : Smell t : Cigarette Burns x : Defective y : Stain</p>

<p>A : Scratch AU : Scratch & Dent B : Modified C : Corrosion G : Stone chip P : Faded S : Rust SC : Rust & Corrosion U : Dent X : Defective Y : Crack, Gap</p>
<p>Remarks (R) Front Seat - Grime - Large / (R) Front Trim - Grime - Small / Rear Seat - Grime - Large / Trunk Room - Worn, Scratch, Cut, Crack - Small / (L) Front Trim - Grime - Medium / (L) Front Floor Mat - Grime - Small / (L) Front Seat - Grime - Medium / Ceiling - Crinkle - Small / Dashboard - Worn, Scratch, Cut, Crack - Minimal</p>	<p>Remarks (L) Front Fender, Molding - Dent - Small / Rear Bumper, Lamps, Panels - Scratch & Dent - Small / Trunk Hood, Rear Gate - Dent - Small / (R) Rear Fender, Molding - Scratch & Dent - Medium / (R) Front Door, Molding - Scratch - Small / (R) Rear Door, Molding - Scratch - Small / (R) Front Fender, Molding - Scratch - Small / Front Bumper, Grille, Lamps - Scratch & Dent - Medium / (L) Mirror - Scratch - Minimal / (L) Front Door, Molding - Rust, Corrosion - Medium / (L) Rear Door, Molding - Scratch - Small / (L) Rear Fender, Molding - Scratch - Minimal / Roof - Dent - Small / Bonnet, Headlight - Scratch - Minimal</p>
