General Information

Make	Toyota	Model	Vios
YOM	2024	Odo Meter Reading	28,102
Registration No.	NKC6663	Chassis No.	PA1B18F37R4256023
CC	1.3	Transmission	CVT
Fuel Type	Gas	Type of Body	Sedan
Colour	Blue

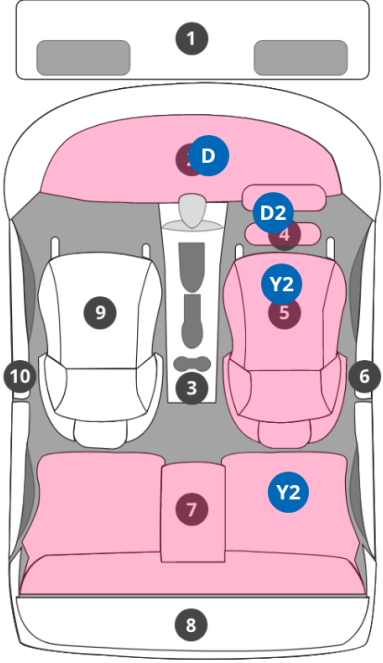
<p>a : Cut, Fray d : Loose, Deformed k : Animal Hair s : Smell t : Cigarette Burns x : Defective y : Stain</p>

<p>A : Scratch AU : Scratch & Dent B : Modified C : Corrosion G : Stone chip P : Faded S : Rust SC : Rust & Corrosion U : Dent X : Defective Y : Crack, Gap</p>
<p>Remarks Rear Seat - Grime - Small / (R) Front Seat - Grime - Small / (L) Front Floor Mat - Worked - Small / Dashboard - Traces of Adhesive Tape - Yes</p>	<p>Remarks (L) Front Door, Molding - Scratch - Minimal / (L) Rear Door, Molding - Scratch - Minimal / (L) Step, In-panel, Side Spoiler - Scratch - Minimal / (L) Rear Fender, Molding - Scratch - Minimal / Front Bumper, Grille, Lamps - Scratch - Small / (R) Front Fender, Molding - Dent - Minimal / (R) Step, In-panel, Side Spoiler - Scratch & Dent - Minimal / (R) Front Door, Molding - Scratch - Minimal / (R) Rear Door, Molding - Scratch - Minimal / Rear Bumper, Lamps, Panels - Scratch - Minimal / Trunk Hood, Rear Gate - Scratch - Minimal / Roof - Scratch & Dent - Minimal / Bonnet, Headlight - Scratch - Minimal</p>
