General Information

Make	Toyota	Model	Innova
YOM	2024	Odo Meter Reading	10,433
Registration No.	NKD2998	Chassis No.	PA2JA8EM5R0141557
CC	2.8	Transmission	A/T
Fuel Type	Diesel	Type of Body	Wagon
Colour	Red Mica Metallic

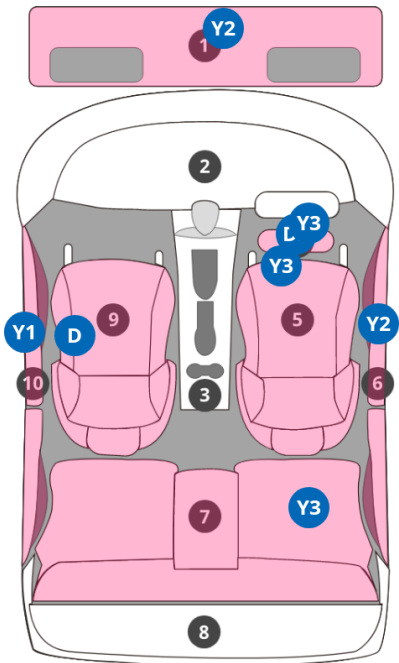
Interior Evaluation : C	Exterior Evaluation : C

<p>A : Scratch AU : Scratch & Dent B : Modified C : Corrosion G : Stone chip P : Faded S : Rust SC : Rust & Corrosion U : Dent X : Defective Y : Crack, Gap</p>
<p>Remarks Rear Seat - Grime - Medium / (R) Front Seat - Grime - Medium / (L) Front Seat - Worn - Yes / (R) Front Trim - Grime - Small / (L) Front Trim - Grime - Minimal / (L) Front Floor Mat - Worked - Small / Mat Other - Grime - Medium / Ceiling - Grime - Small</p>	<p>Remarks (R) Front Fender, Molding - Scratch - Minimal / (R) Front Door, Molding - Scratch - Small / (R) Rear Door, Molding - Scratch - Small / (R) Rear Fender, Molding - Scratch - Minimal / Rear Bumper, Lamps, Panels - Scratch - Medium / Trunk Hood, Rear Gate - Scratch - Minimal / (L) Rear Fender, Molding - Scratch - Small / (L) Rear Door, Molding - Scratch - Small / (L) Front Door, Molding - Scratch - Minimal / (L) Front Fender, Molding - Scratch - Minimal / Front Bumper, Grille, Lamps - Scratch - Medium / Bonnet, Headlight - Scratch - Minimal / Roof - Scratch - Medium</p>

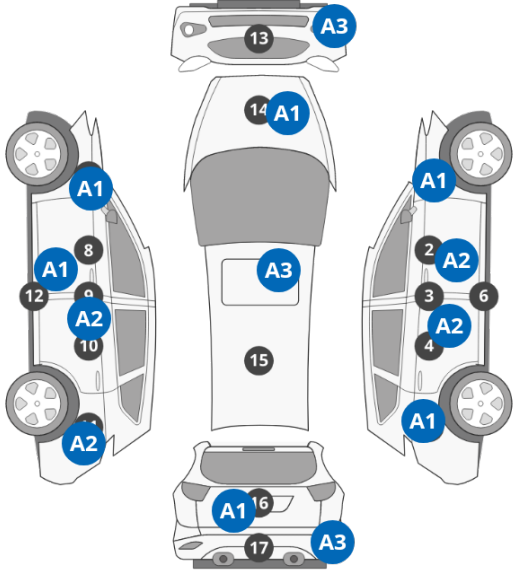
<p>Inspector Notes</p>
<p>with warranty booklet, with jack and tools, with spare tire and LTO PLATE, scratches on tail light</p>
