## General Information

<b>Make</b>	Toyota	<b>Model</b>	Innova
<b>YOM</b>	2025	<b>Odo Meter Reading</b>	29,827
<b>Registration No.</b>	ZAD5263	<b>Chassis No.</b>	PA2JA8EM7R0147165
<b>CC</b>	2.8	<b>Transmission</b>	A/T
<b>Fuel Type</b>	Diesel	<b>Type of Body</b>	Wagon
<b>Colour</b>	Blackish Red Mica

## Body / Panel Condition

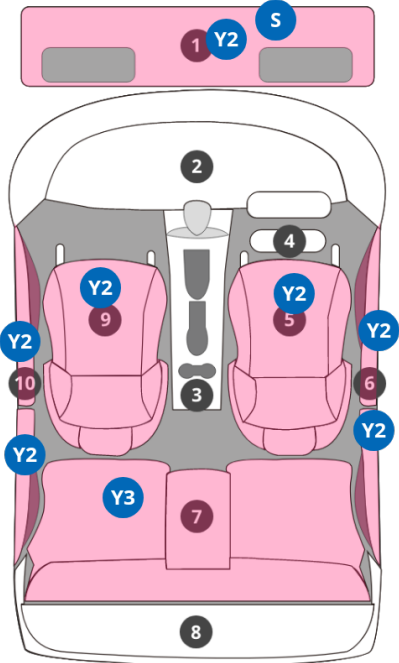
<b>Interior Evaluation :</b> <span style="float: right; color: red; font-weight: bold;">B</span>	<b>Exterior Evaluation :</b> <span style="float: right; color: red; font-weight: bold;">C</span>

<p><b>a</b> : Cut, Fray <b>d</b> : Loose, Deformed <b>k</b> : Animal Hair <b>s</b> : Smell <b>t</b> : Cigarette Burns <b>x</b> : Defective <b>y</b> : Stain</p>

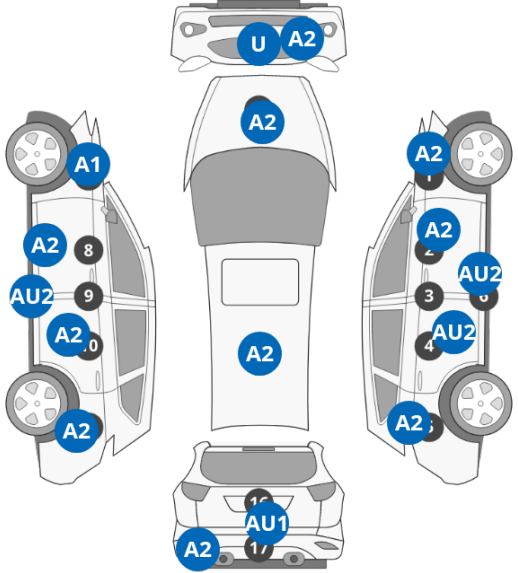
<p><b>A</b> : Scratch <b>AU</b> : Scratch &amp; Dent <b>B</b> : Modified <b>C</b> : Corrosion <b>G</b> : Stone chip <b>P</b> : Faded <b>S</b> : Rust <b>SC</b> : Rust &amp; Corrosion <b>U</b> : Dent <b>X</b> : Defective <b>Y</b> : Crack, Gap</p>
<p><b>Remarks</b> Overall Interior - Smell - Yes / Rear Seat - Grime - Medium / (R) Front Seat - Grime - Small / (L) Front Seat - Grime - Small / (R) Front Trim - Grime - Small / (L) Front Trim - Grime - Small / (L) Rear Trim - Grime - Small / (R) Rear Trim - Grime - Small / Ceiling - Grime - Small</p>	<p><b>Remarks</b> Member (Bolted) - Dent - Yes / (L) Rear Fender, Molding - Scratch - Small / (L) Rear Door, Molding - Scratch - Small / (L) Front Door, Molding - Scratch - Small / (L) Front Fender, Molding - Scratch - Minimal / (L) Step, In-panel, Side Spoiler - Scratch &amp; Dent - Small / Front Bumper, Grille, Lamps - Scratch - Small / (R) Step, In-panel, Side Spoiler - Scratch &amp; Dent - Small / (R) Front Door, Molding - Scratch - Small / (R) Rear Door, Molding - Scratch &amp; Dent - Small / (R) Rear Fender, Molding - Scratch - Small / Bonnet, Headlight - Scratch - Small / Trunk Hood, Rear Gate - Scratch &amp; Dent - Minimal / Rear Bumper, Lamps, Panels - Scratch - Small / Roof - Scratch - Small / (R) Front Fender, Molding - Scratch - Small</p>
